# New York State Department of Transportation

## General Bridge Inspection Report

**Inspection Date:** October 06, 2021

**BIN:** 3342250

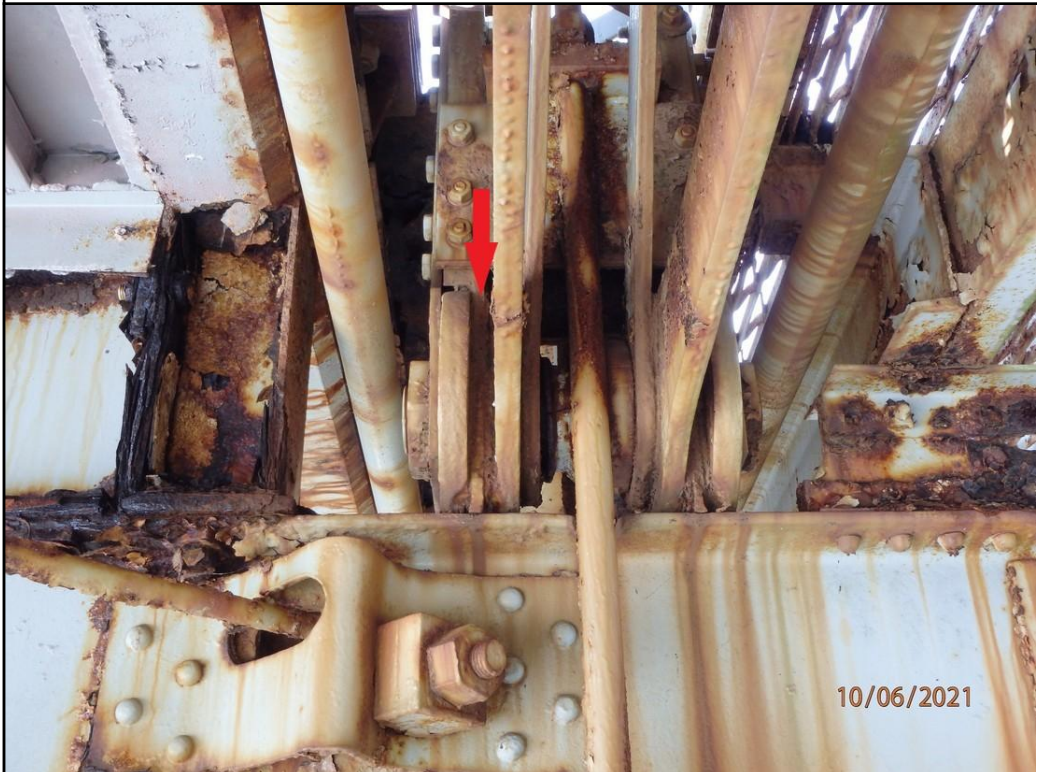
Photo Number: 11

Above deck, Left Truss at U2L2 spacer welds (4' above roadway) are cracked through (crack propagation not possible). Right Truss at L4U4 spacer welds (4' above roadway) are cracked through (crack propagation not possible) (Photos 11 & 12). Right Truss L7U7 (above roadway) is deformed on the inside channel. The channel appears to be pushed away from the roadway. This is not a new condition, no other signs of distress observed (Photo 13). The lacing bars are up to 5' above the roadway are welded to the inboard and outboard channels. On the begin side of the outboard channel the fourth lacing bar weld is cracked through (no propagation possible) (Photo 14).

**Attachment Description:**  
Right Truss, L4U4 End  
Face, Looking: Begin Left

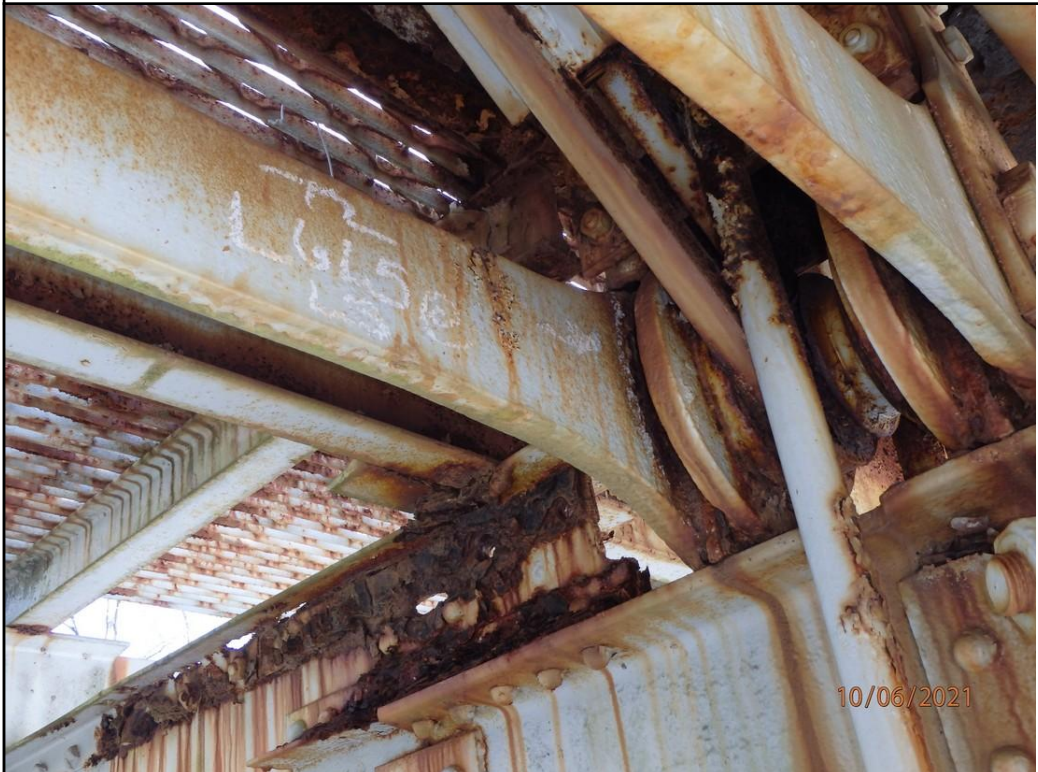
2021: The paint below deck has failed at each panel point (Photo 4). Above deck, the paint has failed or is starting to fail at top chord and at any connection point (Photos 21 & 24). See "NBE 136 - Other Truss" condition note for details. The remaining paint is faded and chalky.

2021: The paint below deck has failed at each panel point (especially at the hanger rods) (Photos 21 & 25). Above deck the paint is starting to fail at top chord and at any connection point. See "NBE 141 - Steel Arch" condition note for details. The remaining paint is faded and chalky.

**Attachment Description:**  
Right Truss at L10, Looking:  
End Right

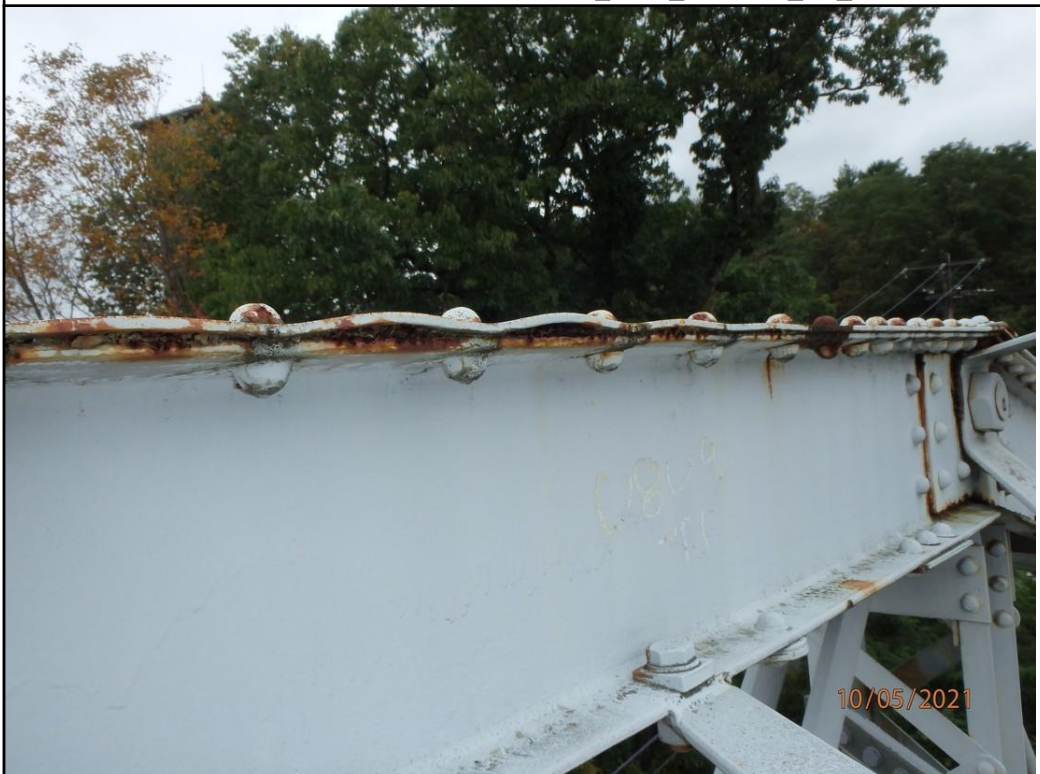
Photo Number: 23

Top Chord:  
Left truss at U1, bolt is unthreaded by 1/8" on the inside face and extends out on outside face. The top plate of the top chords of both trusses are slightly scalloped due to pack rust up to 1/2" (Photo 22). Left truss at U11, the top plate of the top chord is bent up to 1" D due to pack rust. Right truss at U11 the top plate of the top chord plate contains 3 loose bolts on the inboard side and is bent up to 1.2" due to pack rust (Photo 23).

**Attachment Description:**  
Right Truss at U11,  
Looking: End Right

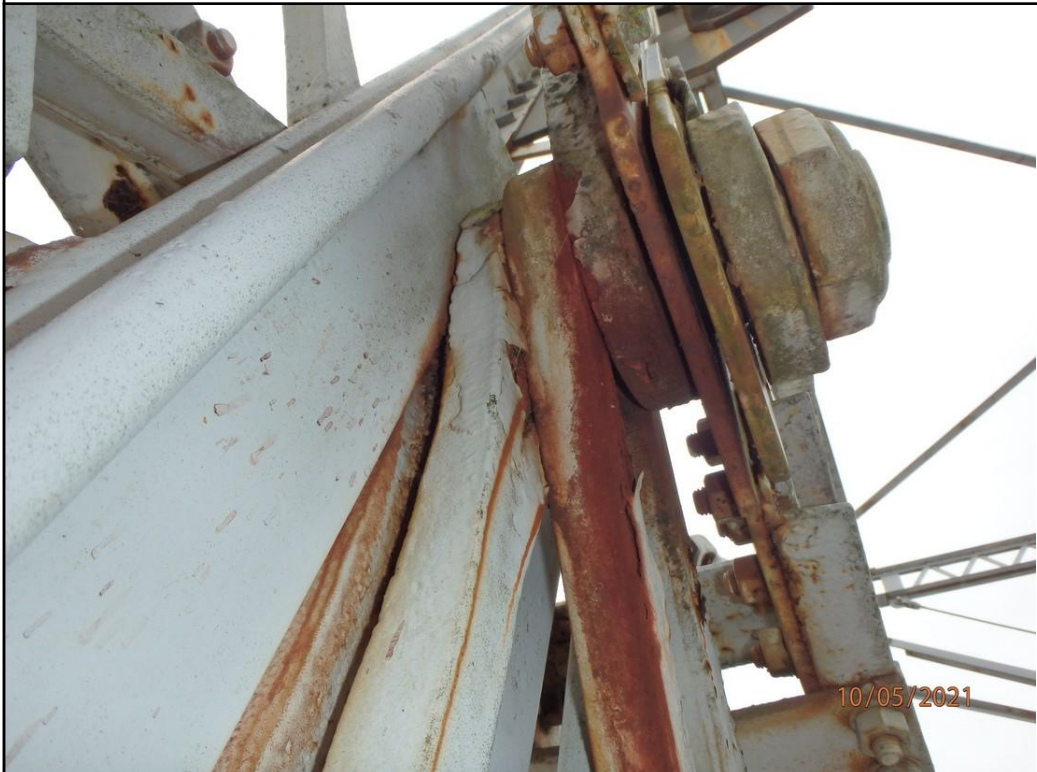
Hanger Rods:  
Below deck, at floorbeam FB0 and all half-numbered panel points (FBX.5) have been retrofitted with 1.5" diameter rods that are bolted to plates under the bottom flanges of the floorbeam. The rods have section losses at the bottom (at the bottom of the floorbeam flange). Access to the rods to measure was difficult due to floorbeam web stiffeners on both sides of them. Overall the section loss is estimated to be 15-20%. Corrosion is active (Photos 25, 26, and 27).

**Attachment Description:**  
Left Arch at Floorbeam FB  
0.5, End Face Hanger,  
Looking: Begin

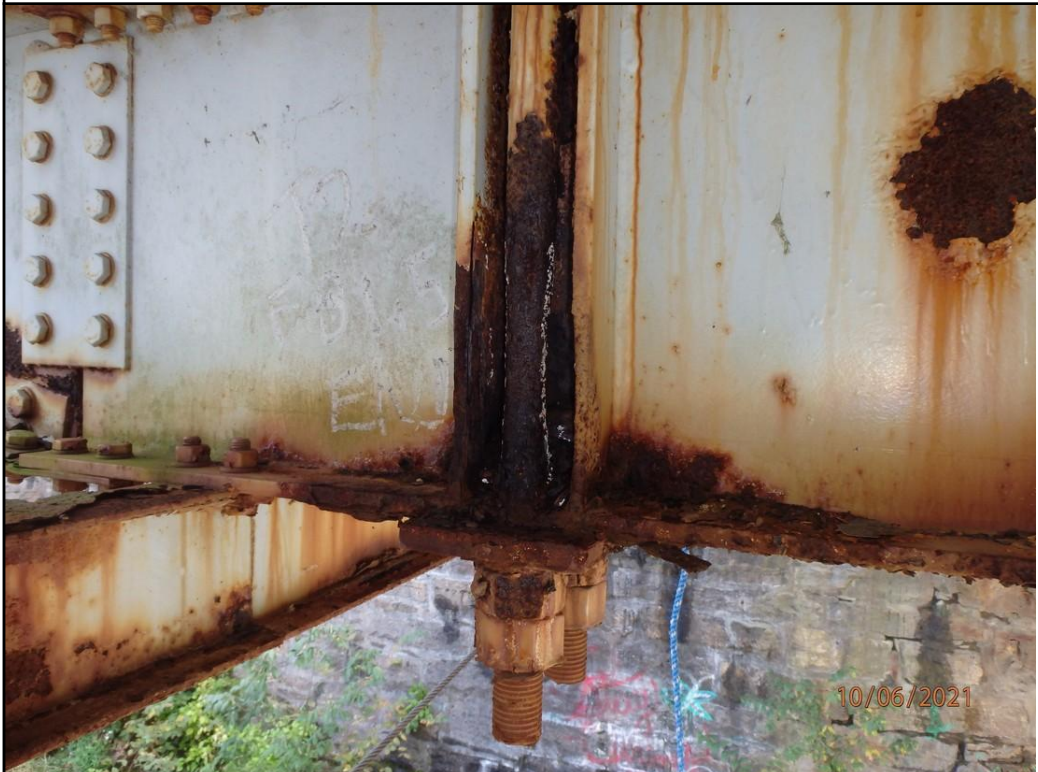
**Attachment Description:**  
Right Arch at Floorbeam FB  
7.5, Begin Face Hanger,  
Looking: End

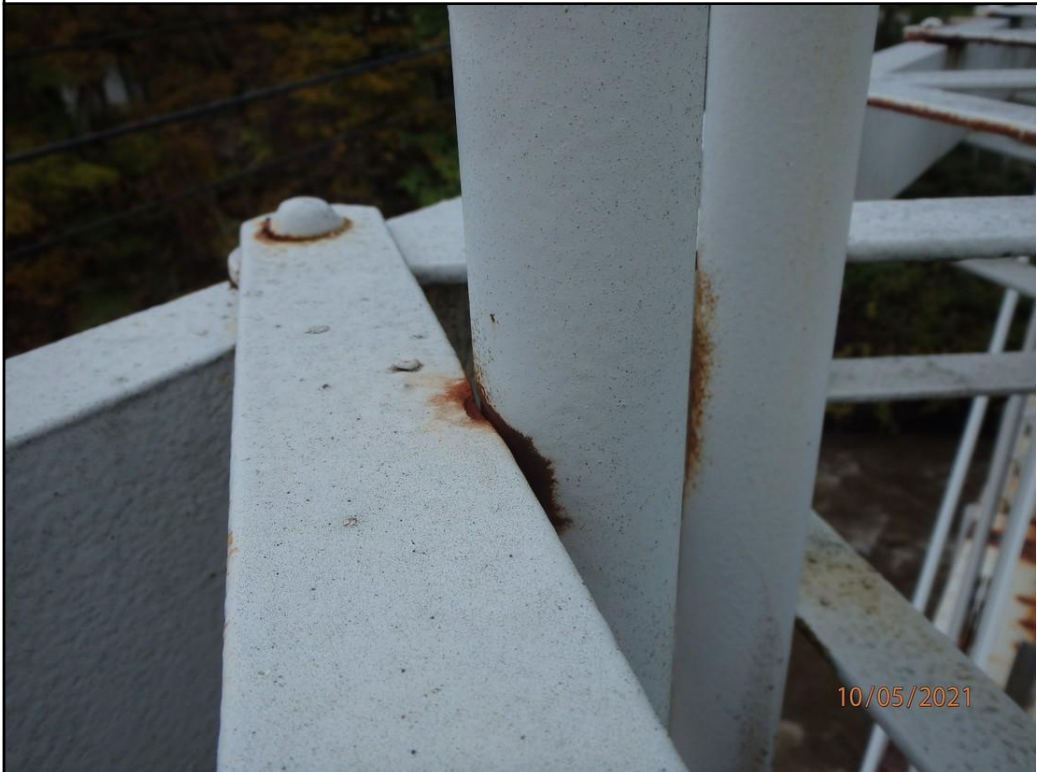
At Right Arch, the hangers at panel points 4.5 and 6.5 all have the hanger rods pressed against lacing bars of the middle chord and have section losses/wear of up to 1/16" over a 1" H area. The section loss is 5% overall (Photo 29).

**Attachment Description:**  
Right Arch at Panel Point  
4.5, Looking: Down & Begin  
Right

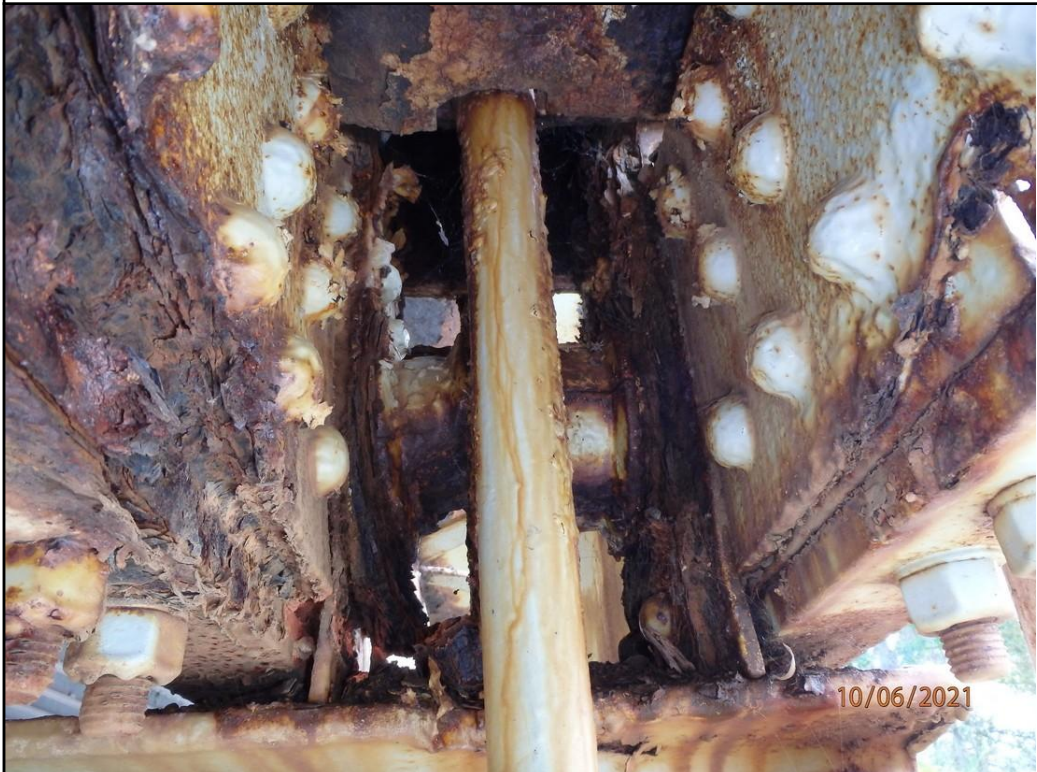
| 2021: Below deck - the original pin assemblies below deck have pack rust between the members (bottom chord, diagonal, vertical members) on both trusses. Due to paint failure the corrosion and rust is now active (Photos 36 & 37). At the Left Truss, L1 (begin side) has a cracked spacer. At the Right Truss, L1 has a cracked spacer (Photo 38). At the Right Truss, L5 (begin face) has a cracked spacer on the left side of the hanger rod (Photo 39). No signs of distress were observed to the assembly at the above locations.<br><br>Above deck, the pins at mid-height have fine rust powder around the pinned connections at M4 and M6 at both left and right trusses and M10 at left truss. This indicates the steel members are grinding against each other (Photos 24 & 40). The upper truss connection pins, at both the left and right trusses, are not completely tightened and the nuts are not fully engaged at U1 and U11 and at the left truss, U7 outboard nut. This is an old and stable condition, no changes from previous inspection (Photos 41 & 42). At the Left Truss, U11 the inside pin collar/spacer is falling out. Pin is in good condition and no movement noted on the pin nuts (Photo 43).<br><br>This hybrid bridge is not able to be load rated with NYSDOT's BrR software. A Level One load rating is strongly recommended to assess the significant deterioration which has occurred since the 1992 rehabilitation. | | | | | | |

**Attachment Description:**  
Right Truss, L5 Begin Face,  
Looking: Up & End

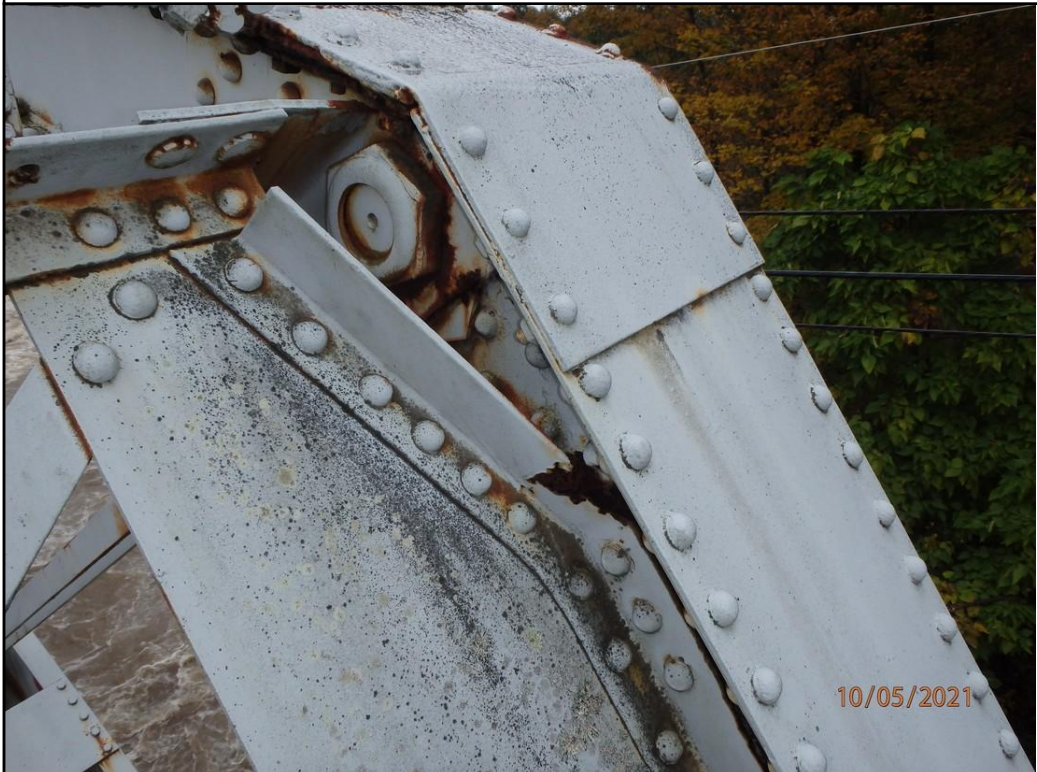
**Attachment Description:**  
Right Truss End Portal  
(U11L12) at End  
Connection Angle Pack  
Rust, Looking: End Right

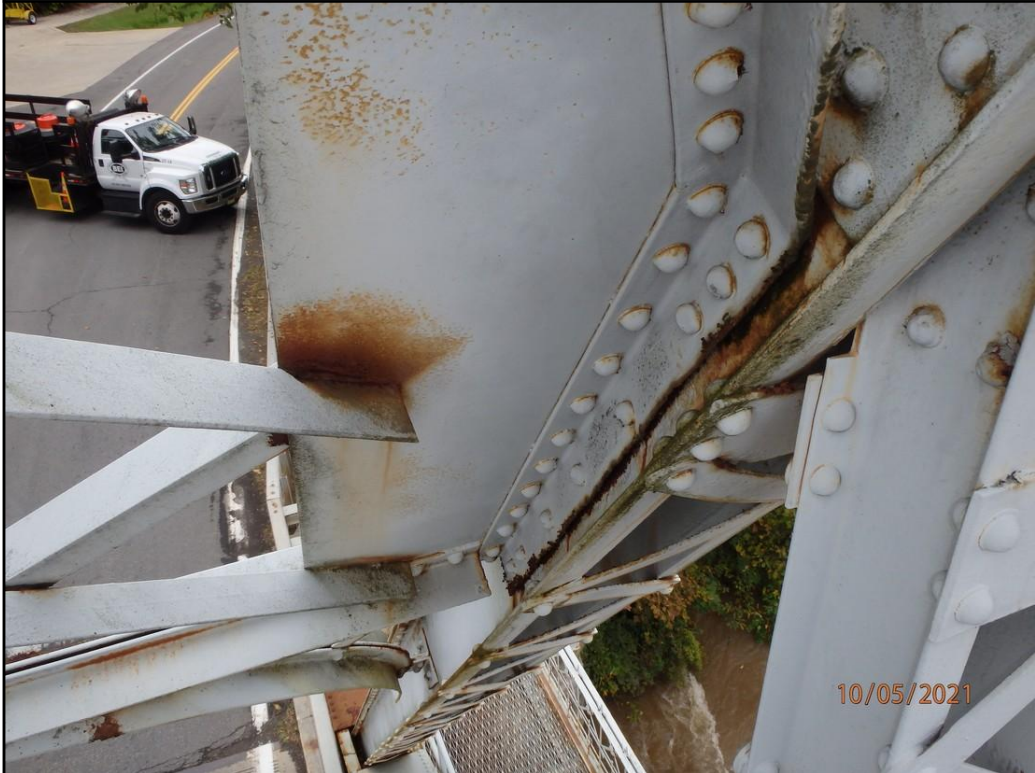
Photo Number: 58

**Attachment Description:**  
Left Truss Begin Portal  
(L0U1) at Begin Connection  
Angle Pack Rust, Looking:  
Begin Left

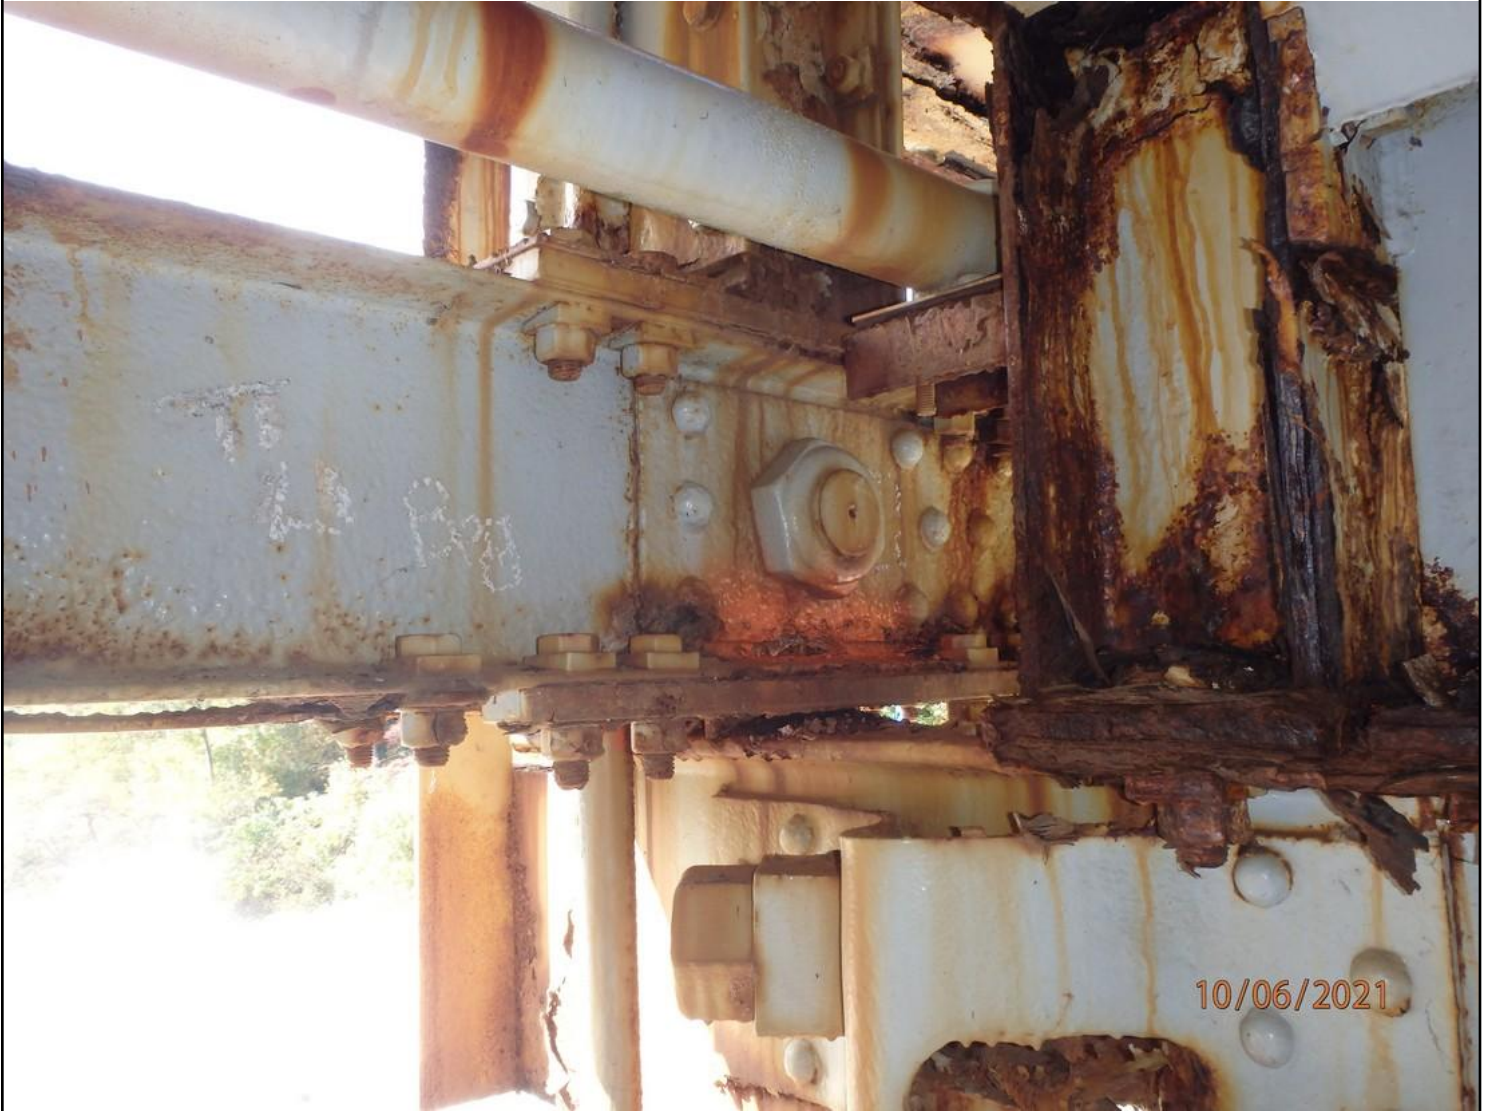
**Attachment Description:** Left Truss at L1, Inboard (Right) Channel, Begin Side Web Perforation, Looking: End Left

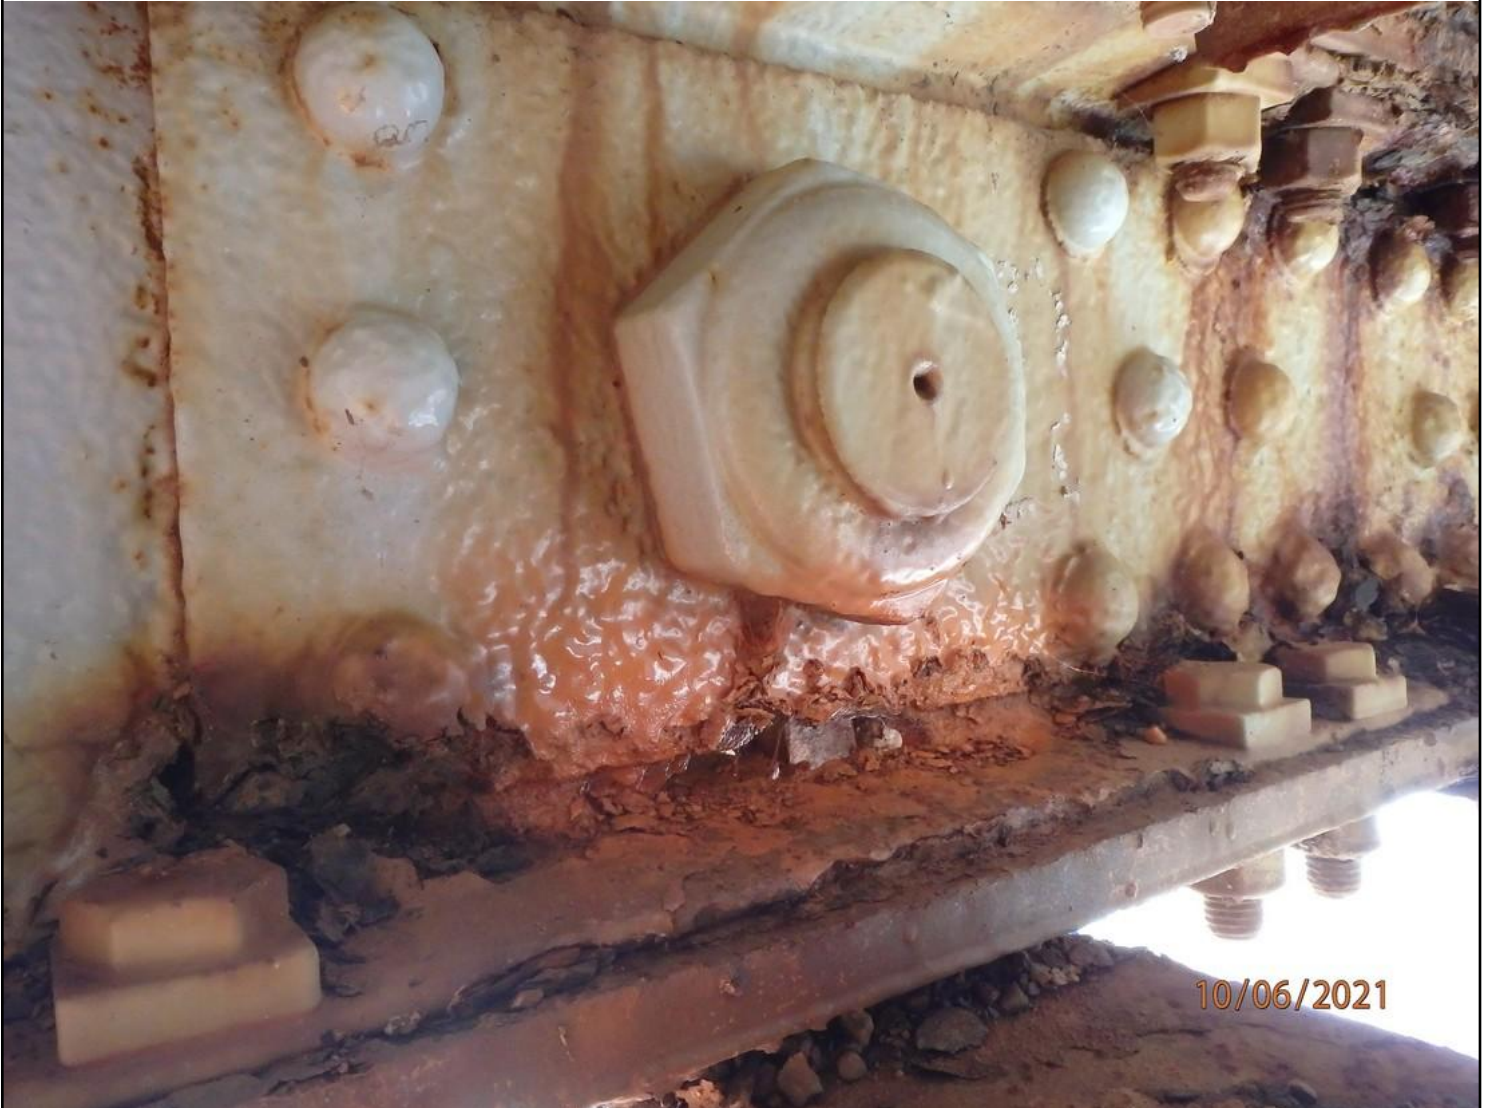
**Attachment Description:** Left Truss at L1, Inboard (Right) Channel Left Face, Begin Side Web Perforation, Looking:  
End

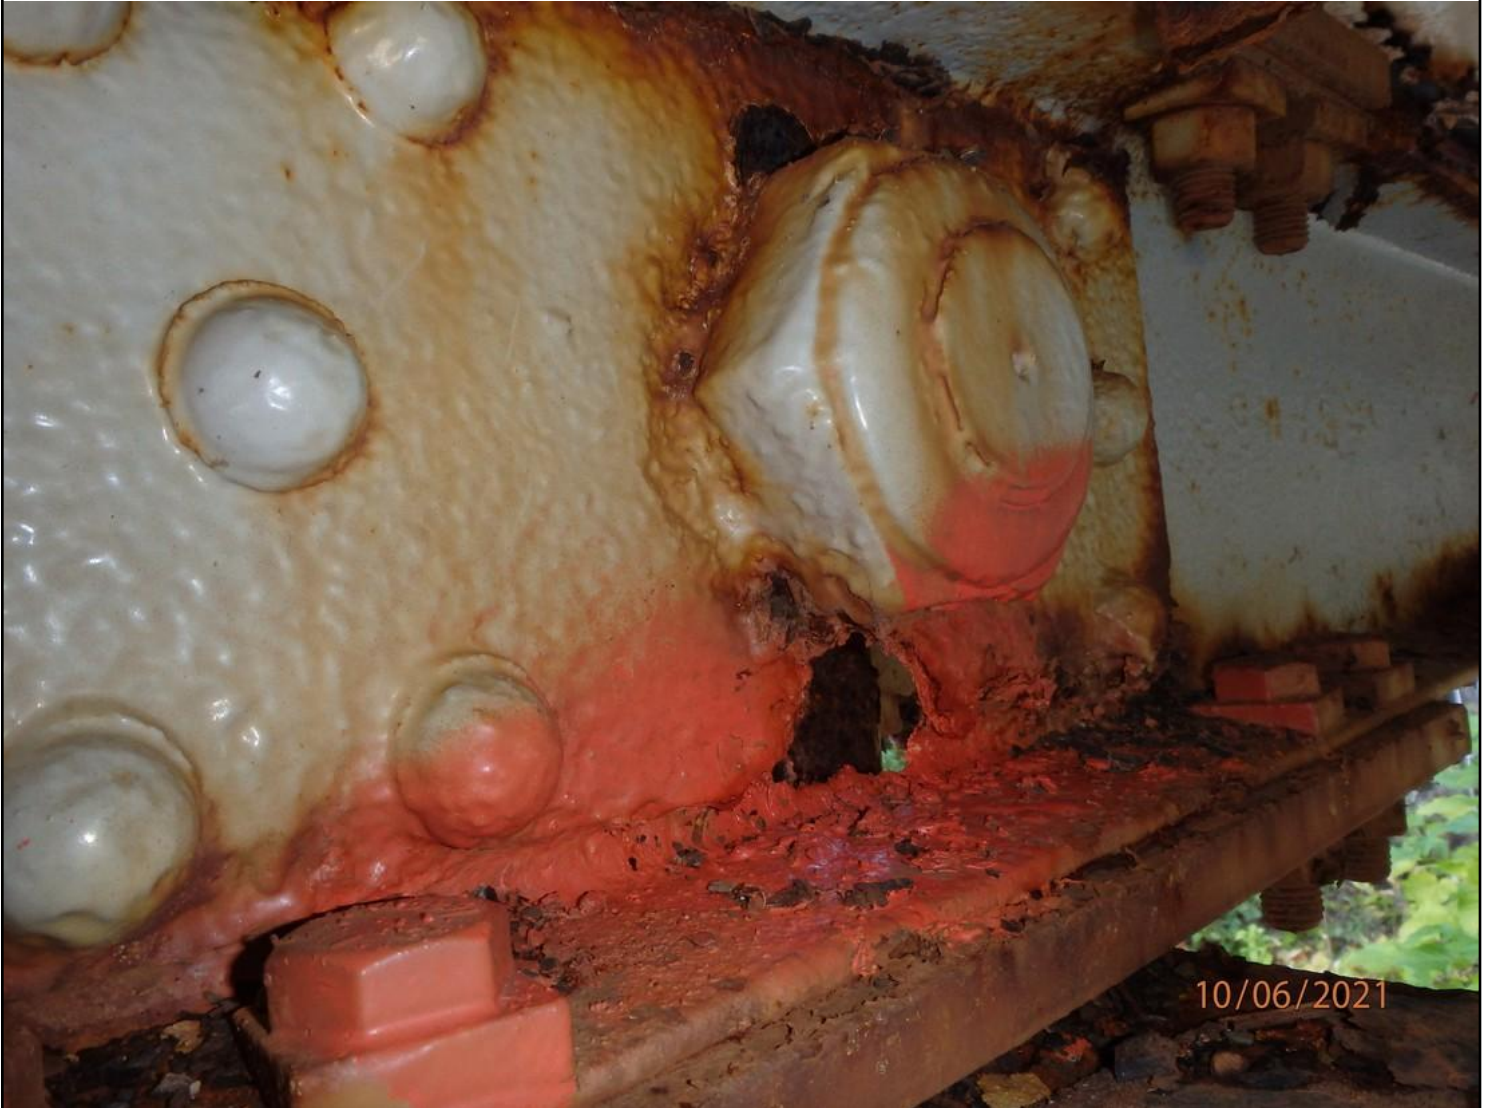
**Attachment Description: Left Truss at L11, Both Channel Web Perforation, Begin Side, Looking: End**

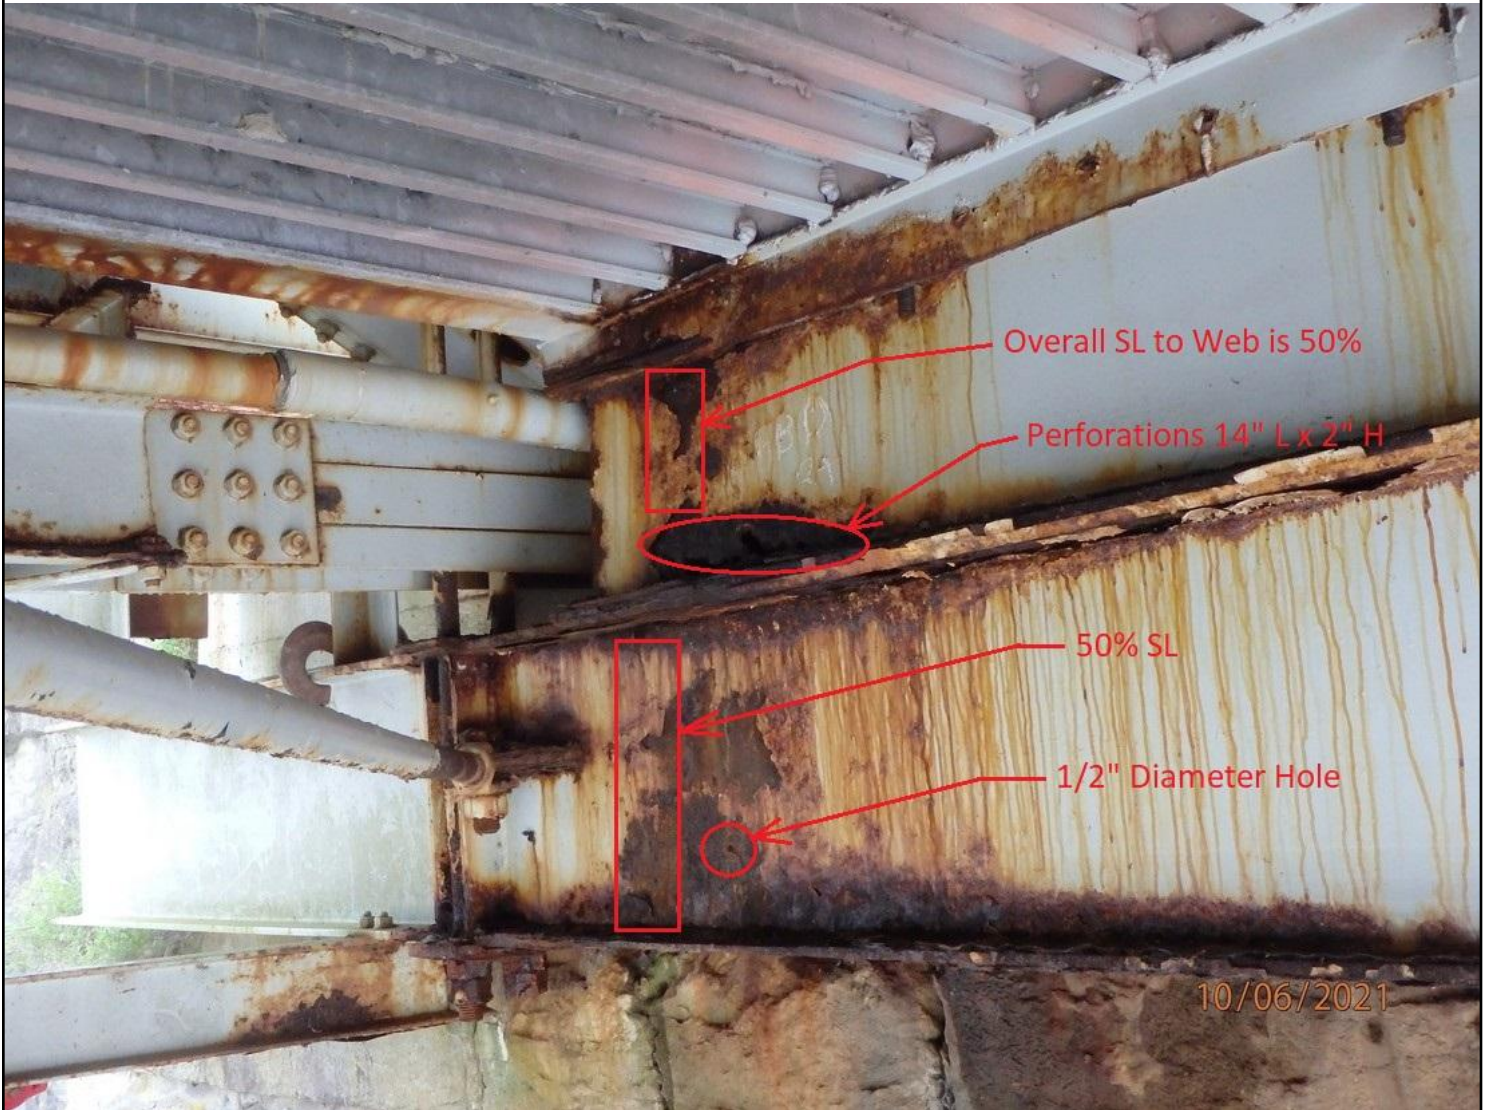
**Attachment Description:** Floorbeam FB0 at Right at Hanger Rod Connection, Section Loss to Rod, Looking: Begin
