**New York State Department of Transportation**  
**Yellow Flag 8B2305W029**

*BIN:* 3342250  
*Feature Carried:* COUNTY ROAD 25A  
*Feature Crossed:* KINDERHOOK CREEK  
*Orientation:* 1 - NORTH  
*Region:* 08 - POUGHKEEPSIE  
*County:* COLUMBIA  
*Political Unit:* Town of STUYVESANT  
*Approximate Year Built:* 1899  
*Posted Load Matches Inventory :* Yes  
*Bridge Load Posting (Tons) :* 12  
*Primary Owner:* 30 - County  
*Primary Maintenance Responsibility:* 30 - County  
*Typical or Main Span Type:* 3 - Steel, 10 - Truss - Thru  
This Bridge is not a Ramp  
*Number of Spans:* 1

Yellow Flag 8B2305W029 issued (supersedes YF 8B22VLW034)

Subject: Section losses to Floorbeam FB0 Web at Right

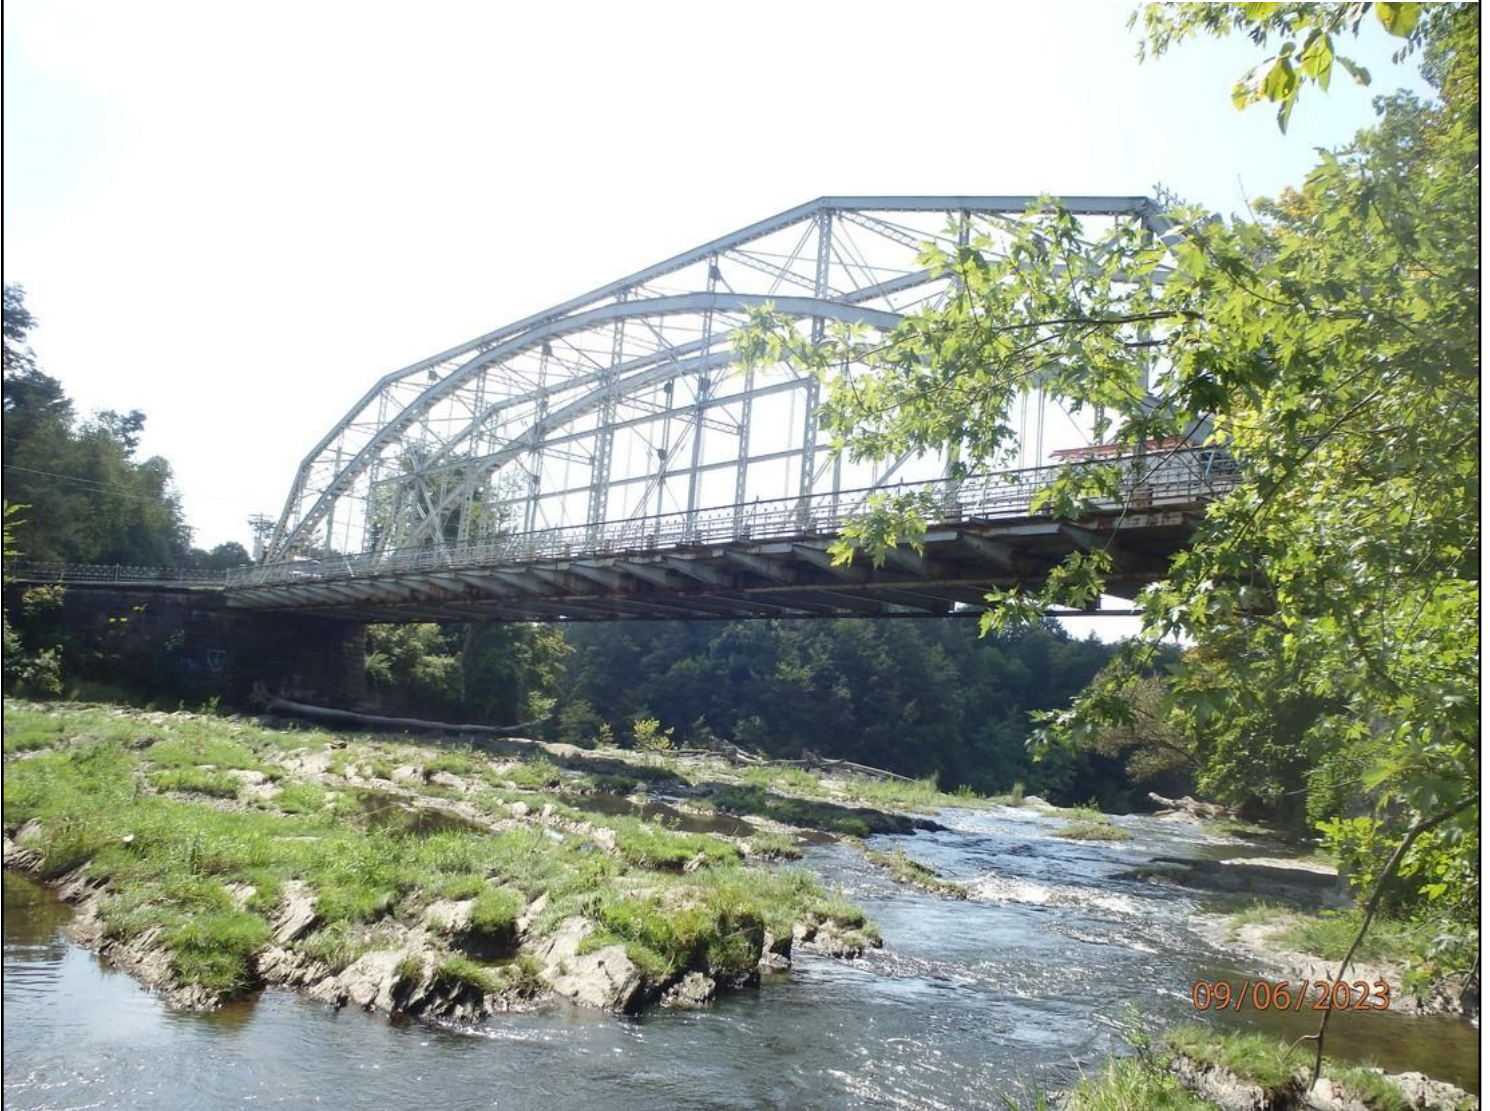
Photo Number: 1

2023: This is a historic pinned truss that has been rehabilitated with the addition of a suspended arch (Photo 1). The truss and arch function together. The original truss supports the original floorbeams and the arch supports the new floorbeams located between the original floorbeams (Photo 2). The panel points on the original truss have been used for the numbering convention, therefore the new floorbeams are labeled as X.5. Bridge is load posted for 12 Tons (Photo 3).

**Attachment Description: Right Elevation, Looking: Begin Left**

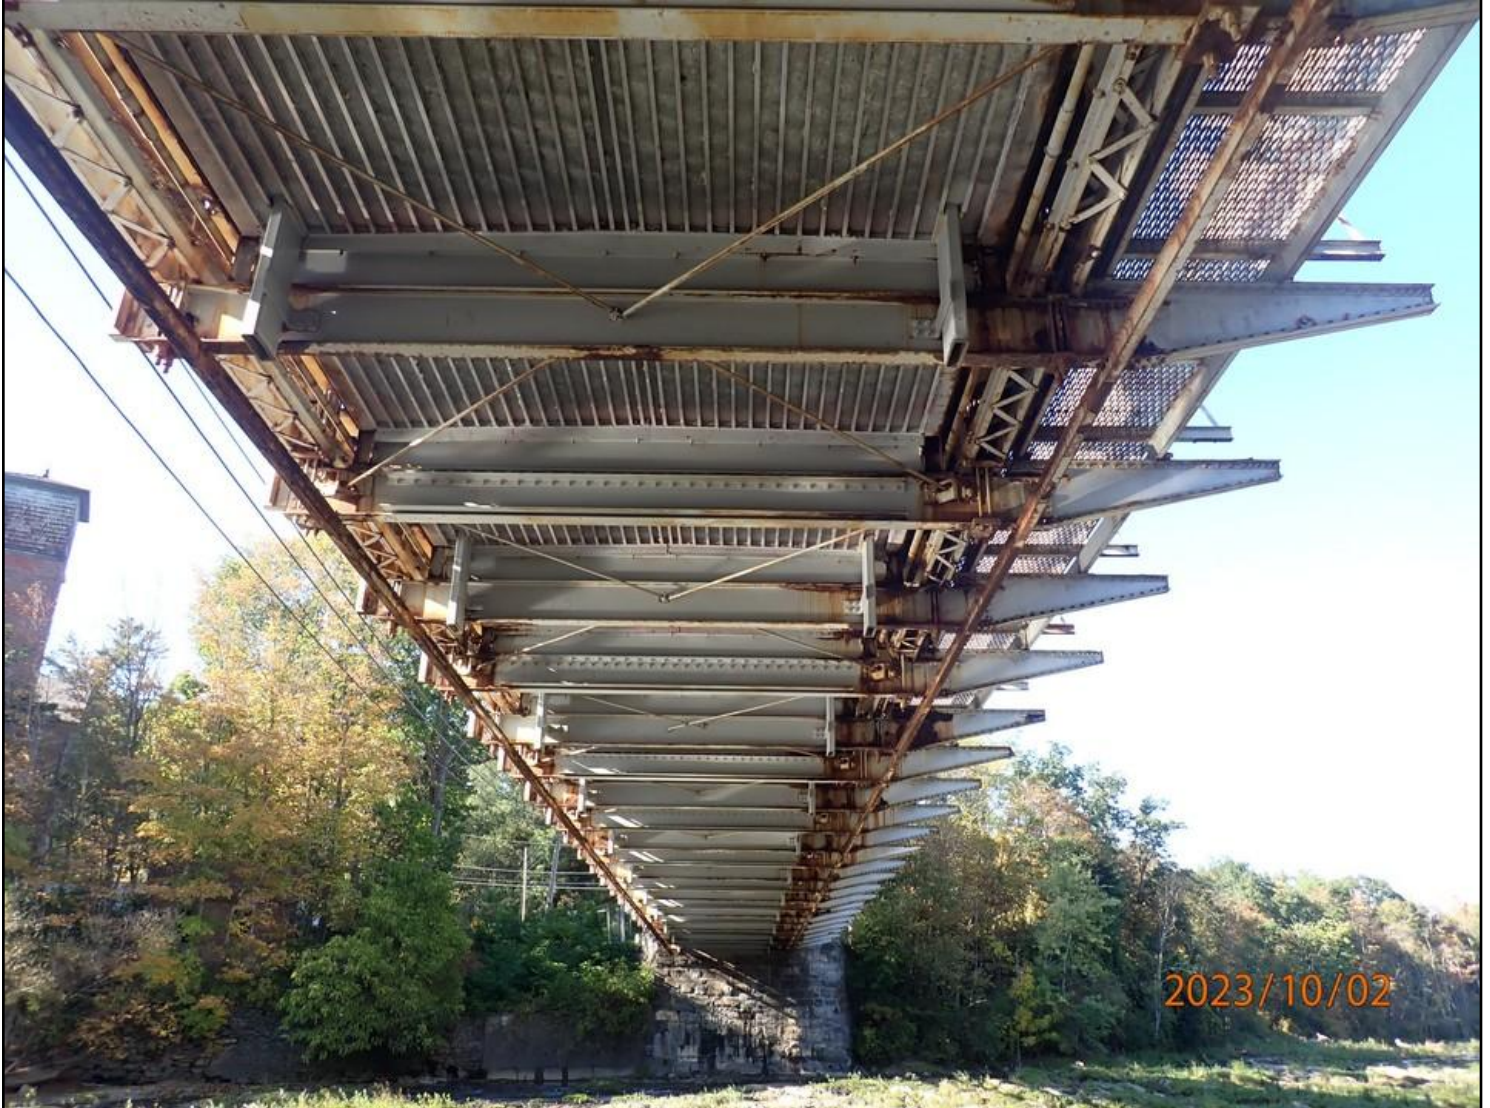
Photo Number: 2

***Attachment Description: Framing, Looking: Up & End***

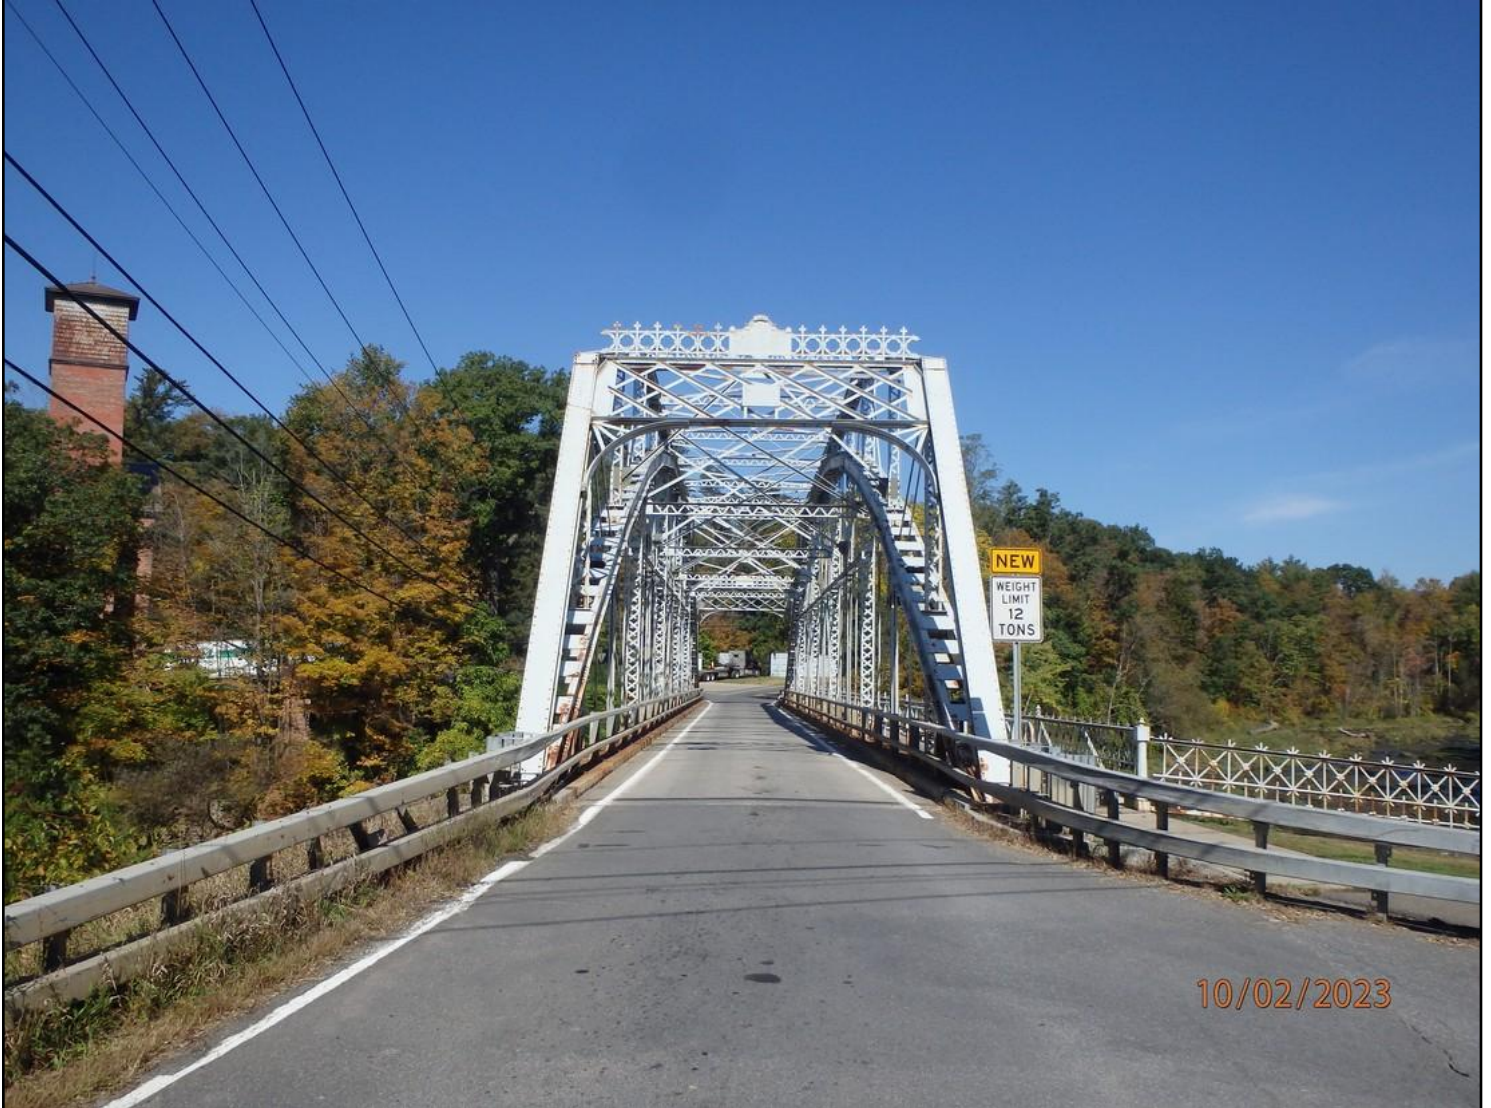
Photo Number: 3

**Attachment Description: Begin Approach with Load Posting Sign, Looking: End**

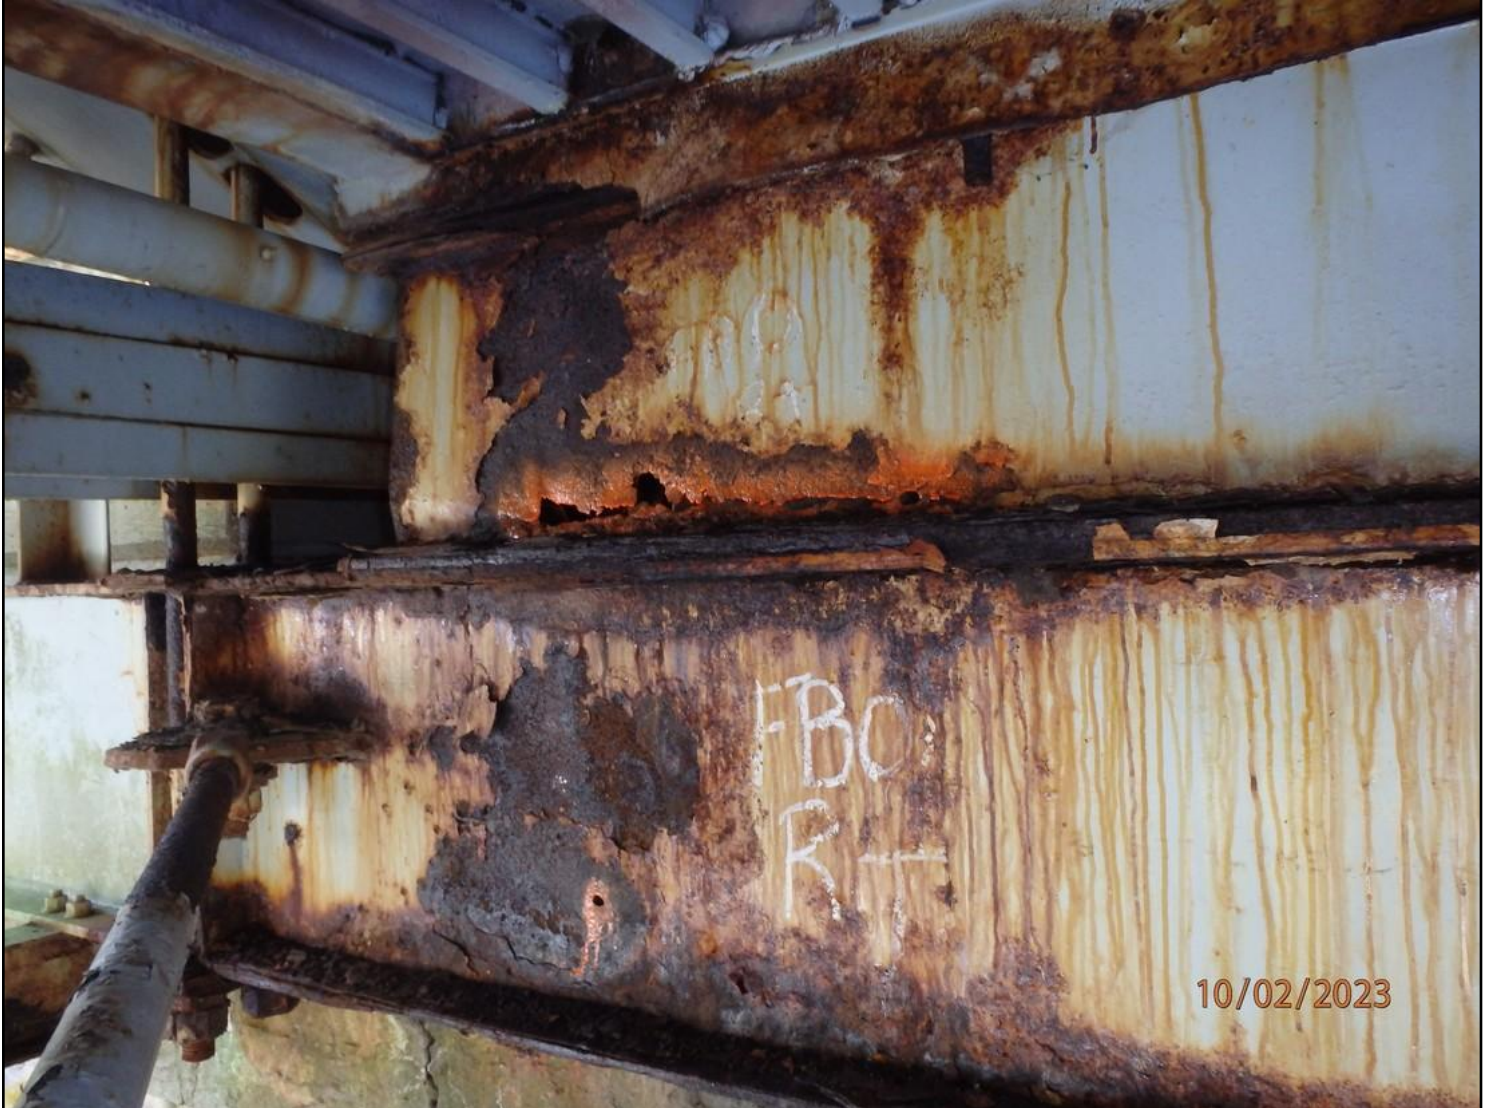
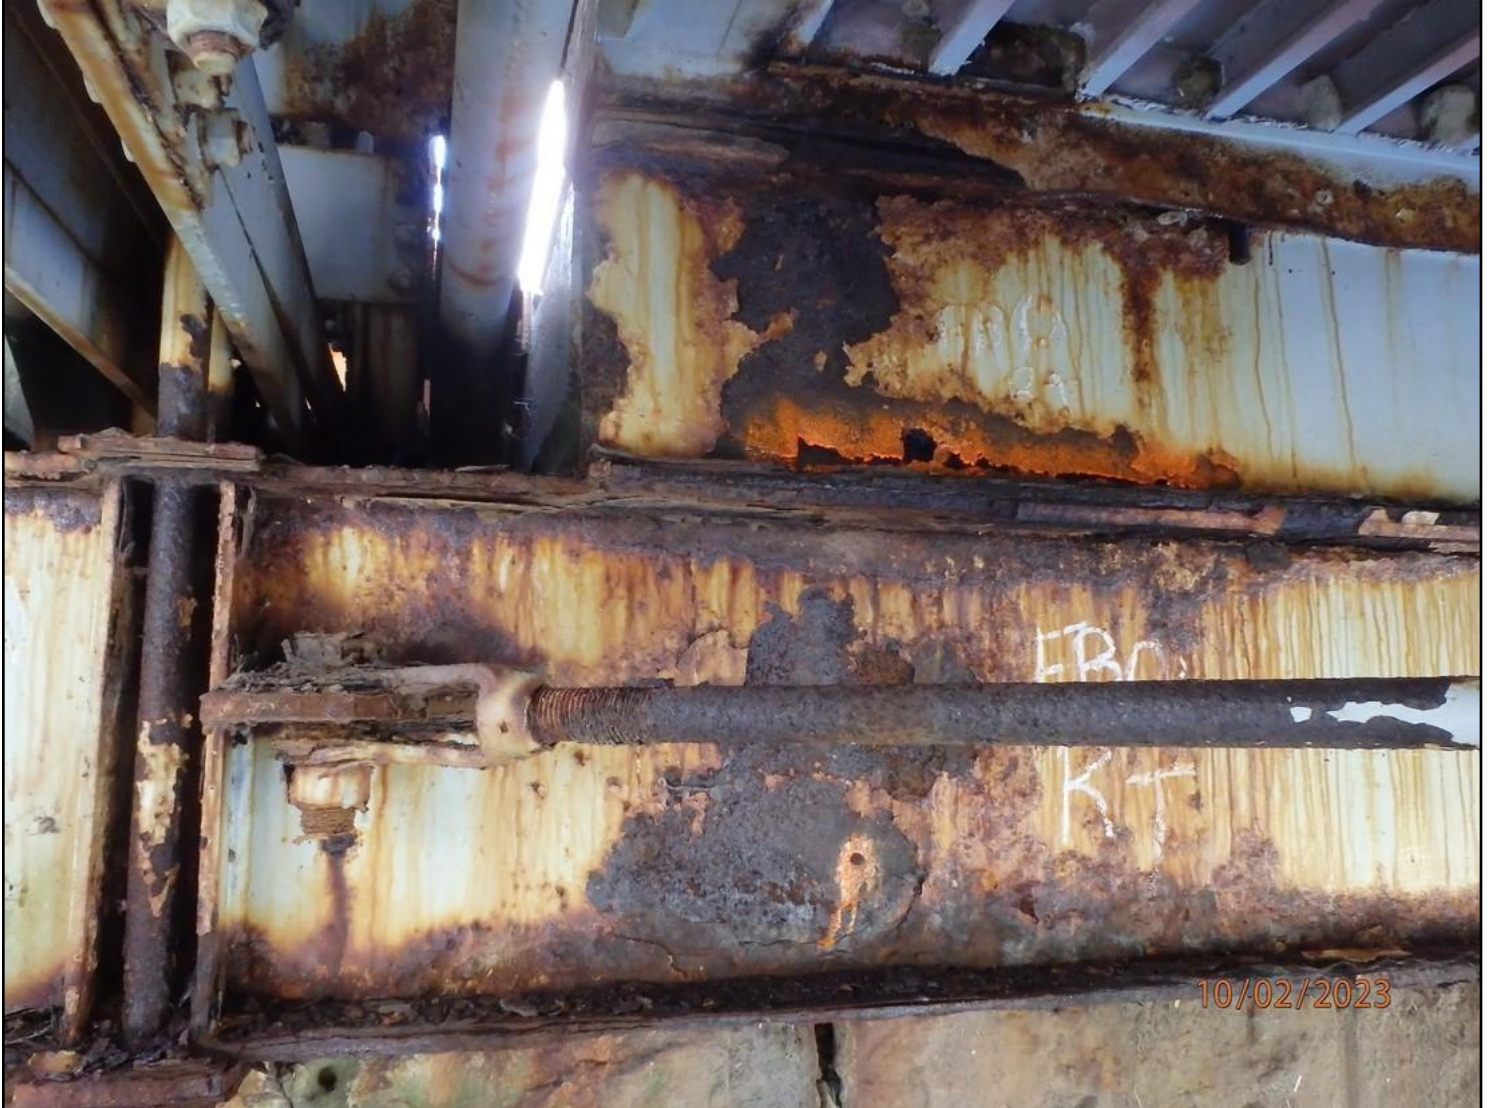
At the begin floorbeam (FB0) right side, there is heavy corrosion and section losses with perforations to the webs of both floorbeams, approximately 2' from the hanger rods (from the inside of the rods, directly under the deck). There are two floorbeams welded together with the top floorbeam being called a "sleeper" floorbeam. The top floorbeam web is 0.3" and the bottom floorbeam web is 0.378" thick. D-meter readings were taken on both the top and bottom floorbeams. The top "sleeper" floorbeam, has a perforation on the lower web measuring 16.5" L x 2" H (2022 – perforation was 16" L). The section losses calculated with the hole is 58% (2022 – was 50%). In addition, since the top "sleeper" floorbeam bears directly on the bottom floorbeam, the edge of the lower web adjacent to the hole is bent (crippled) 1/2" towards the end side. Although this is newly reported during this inspection, a slight bend or crippling can be seen in previous inspection photos. There is no loss of elevation to the deck. The bottom floorbeam has section loss readings at 64% (2022 - was 60%), with a 1/2 in diameter hole in the lower portion of the web (Photos 4 & 5).

A yellow flag is issued due to the nature of this bridge and its configuration. This section loss at the floorbeam has gotten worst over the past several inspections. There are some minor changes since the last inspection; however, since the bridge is posted for 12 tons and is inspected annually, a red flag is not warranted at this time.

**Attachment Description: Floorbeam FB0 at Right, Looking: Begin Right**

**Attachment Description: Floorbeam FB0 at Right, Looking: Begin Left**

This hybrid bridge is unratable with NYSDOT's BrR software. A Level One load rating is strongly recommended to assess the significant deterioration which has occurred since the 1992 rehabilitation.

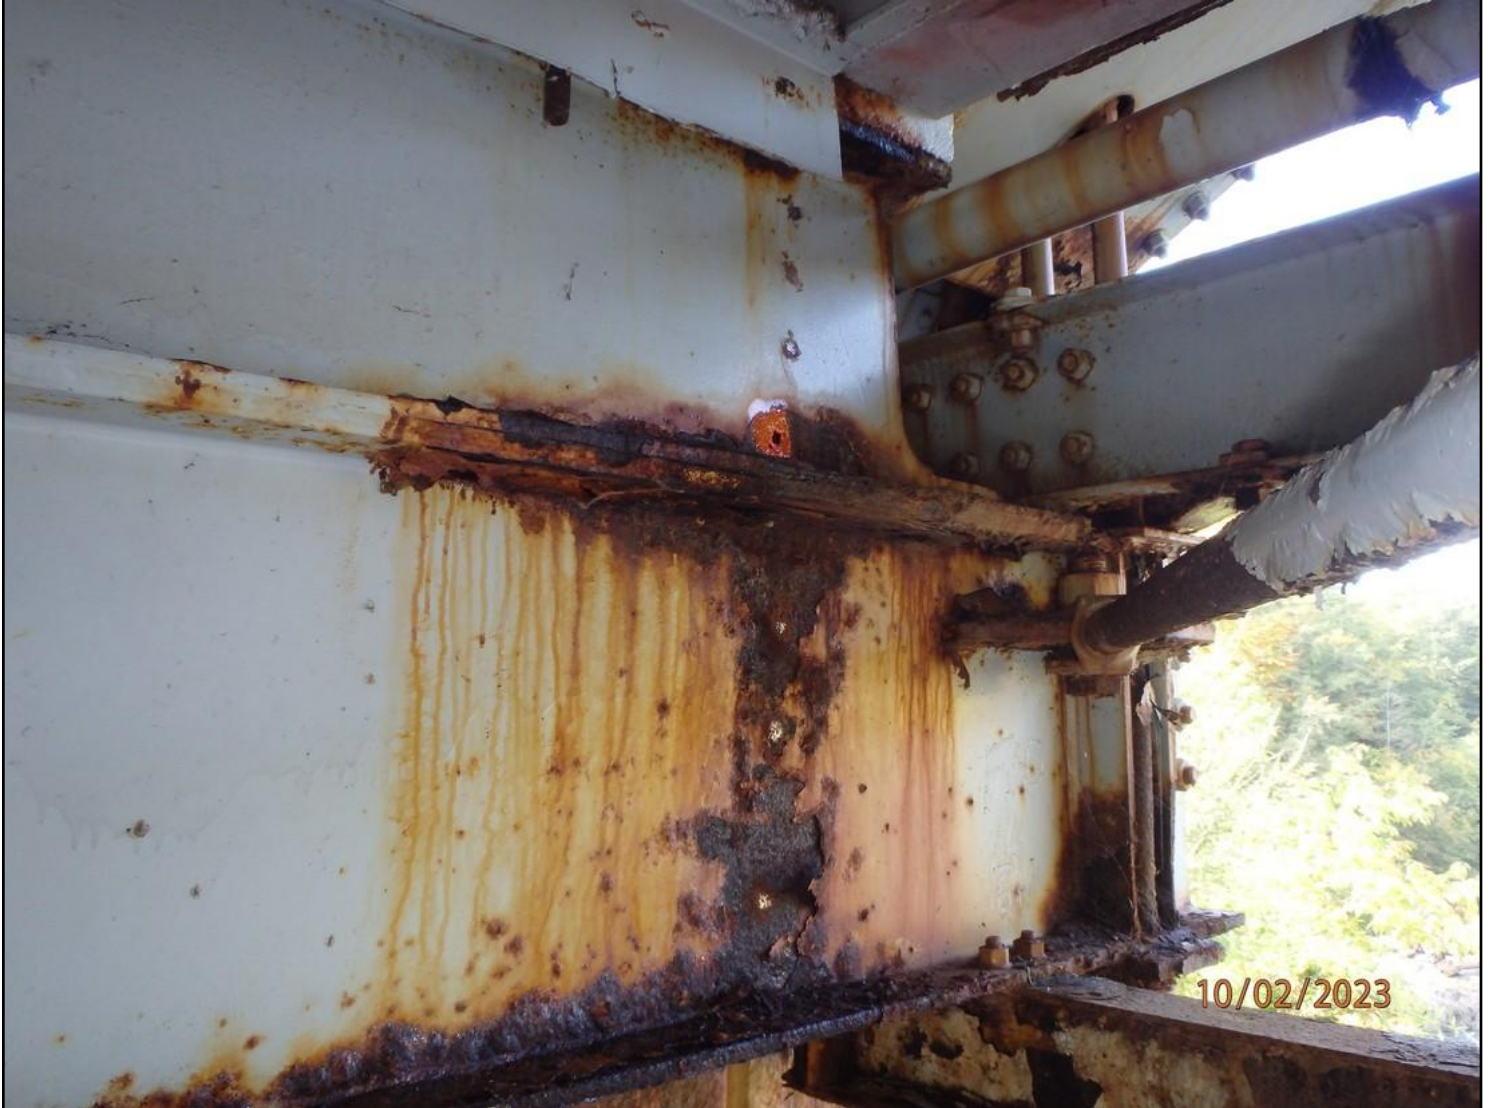
Photo Number: 6

The begin floorbeam (FB0) at left side also has corrosion and section losses. Readings were taken approximately 18" from the hanger rod (under the bridge). The top floorbeam web has 43% (2022 – was 40%) with perforations along the bottom of the web for an area of 1" x 1.5". The bottom floorbeam web section loss is 29% (2022 – was 30%) (Photo 6).

***Attachment Description: Floorbeam FB0 at Left, Looking: Begin Left***
