# New York State Department of Transportation

## Red Flag 8B250TW041

**BIN: 3342250**

Subject: Severe Section Loss to Right Truss Member L9-L10 at L10

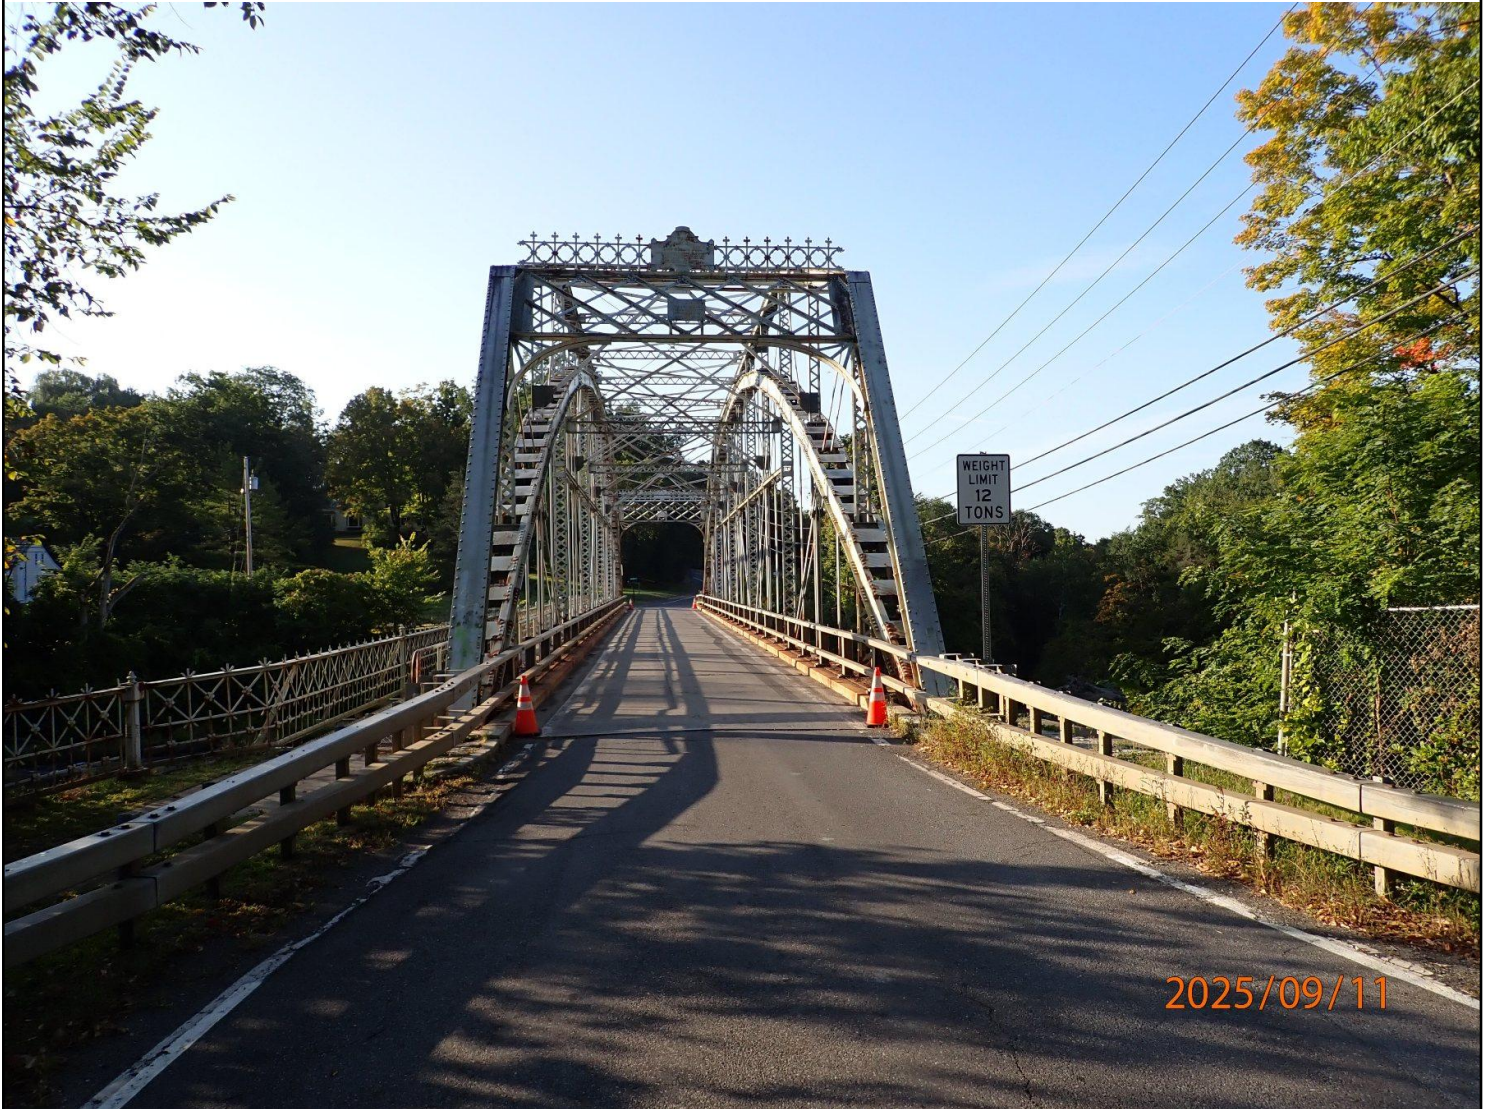
Photo Number: 1

**Attachment Description: General View – End Approach & Top of Deck, Looking Begin**

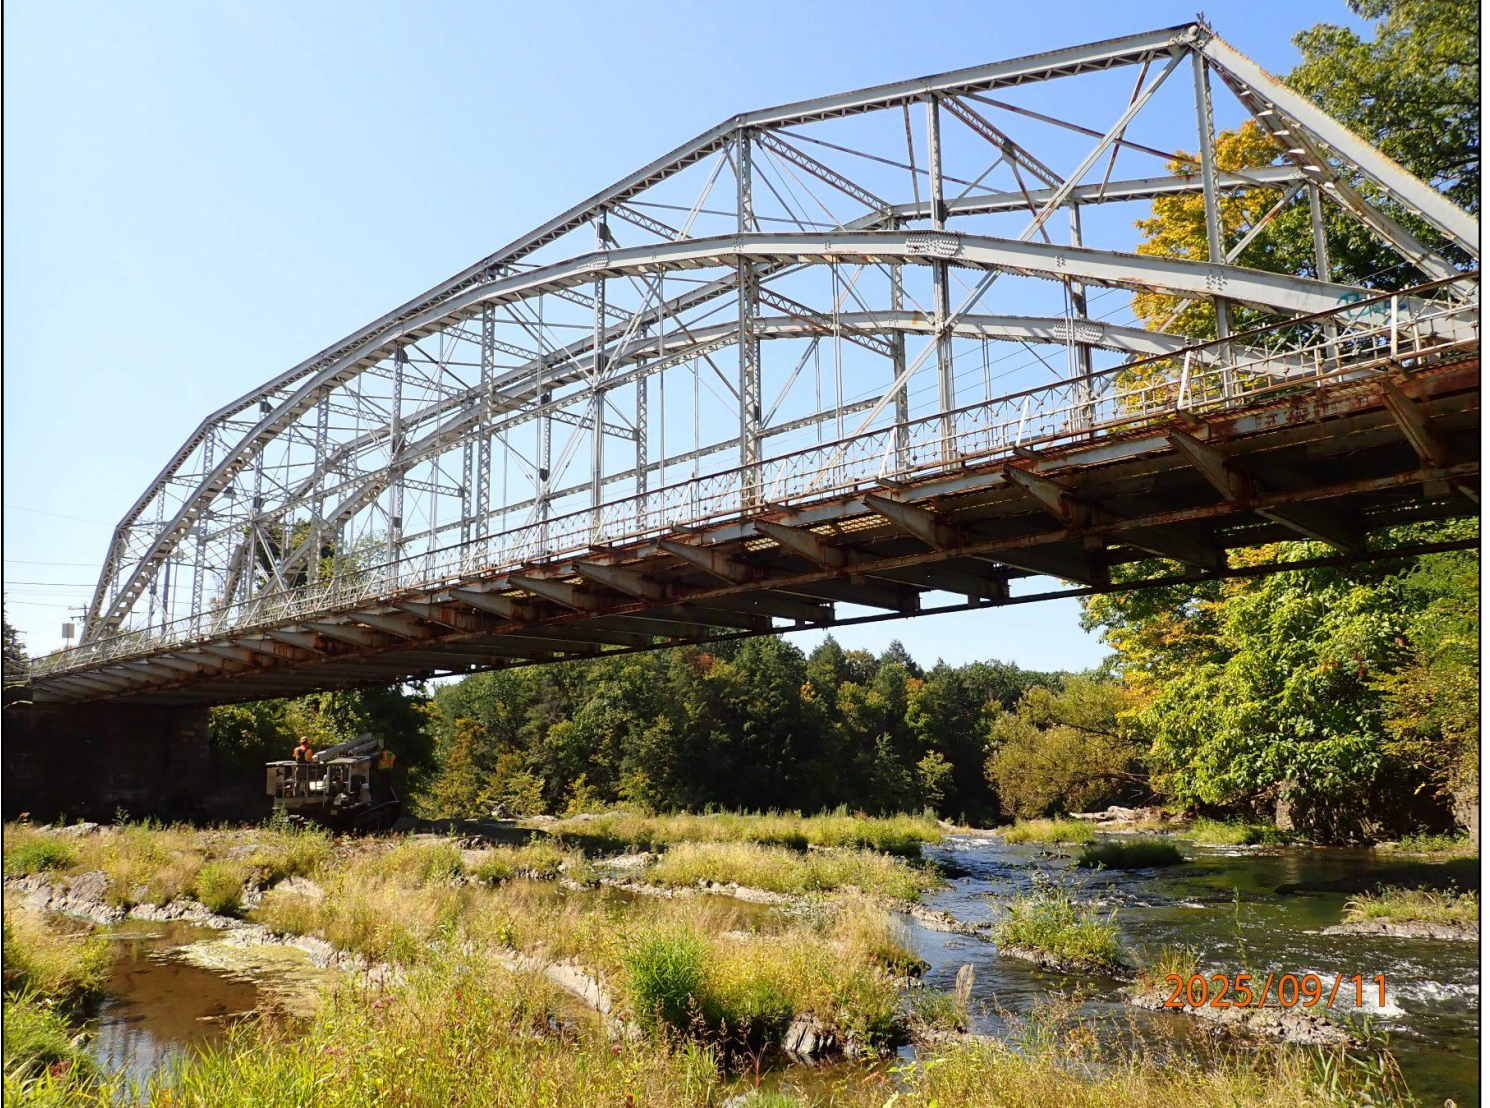
Photo Number: 2

***Attachment Description: General View – Right Elevation, Looking Begin Left***

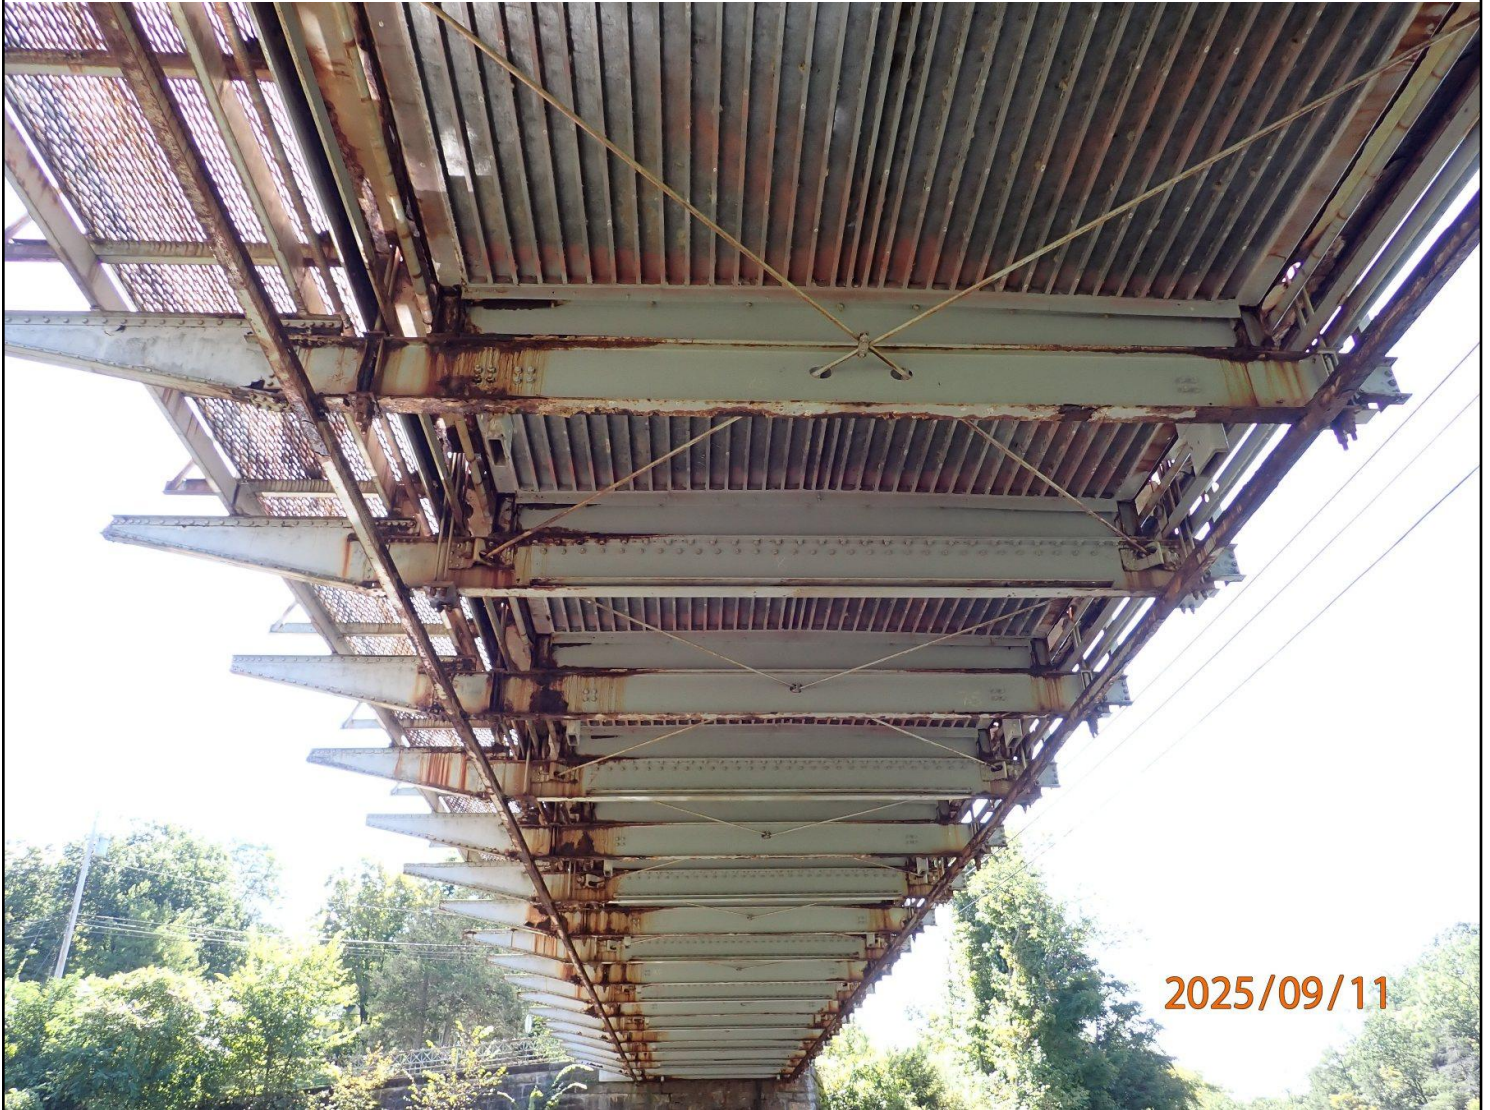
Photo Number: 3

This structure is a historic wrought iron pinned through truss that has been rehabilitated with the addition of a steel arch with longitudinal post-tensioned steel rods (photos 1-3). The truss was originally constructed in 1899 and the arch was constructed in 1992. The truss and arch function together to support the roadway framing with newer hanger rods installed in 1992.

**Attachment Description: General View – Underside of Superstructure, Looking Begin**

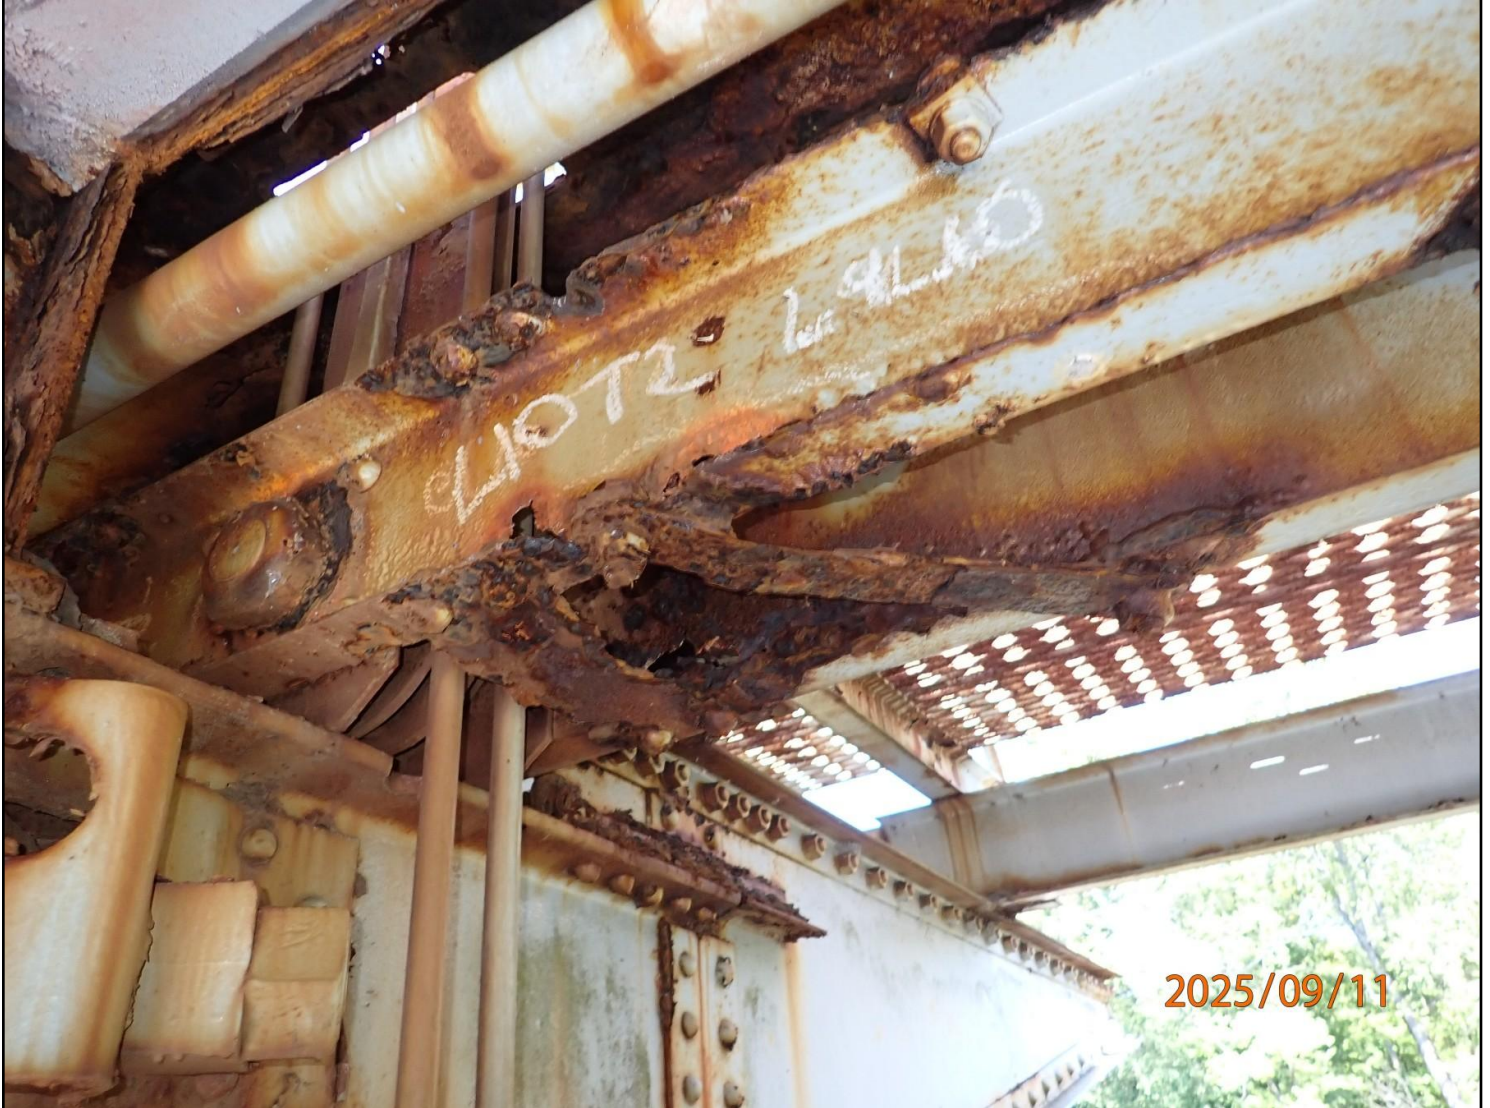
Photo Number: 4

Right truss member L9-L10 at L10 is heavily corroded with severe section losses just before the panel point (photo 4). Conditions are as follows:

Overall member section loss is 51% (was 35%).

This flag has been upgraded to a Red Flag due to the increased deterioration found. Current/further section loss at this location could result in a reduced load carrying capacity of the bridge. Failure of this member would result in collapse of the bridge. Overloads were seen crossing the bridge during the inspection.

**Attachment Description: Right Truss, L9-L10 at L10, Looking End Right**

This hybrid structure is unratable in NYSDOTs BrR load rating software. Ryan-Biggs performed a level 1 load rating (L1LR) in 2014 which was updated in March 2022. The current section losses for this member are not included in that load rating. As such, it is unknown if the current 12 ton posting is adequate for these increased section losses. An updated L1LR to reflect the current conditions noted in this flag is strongly recommended.

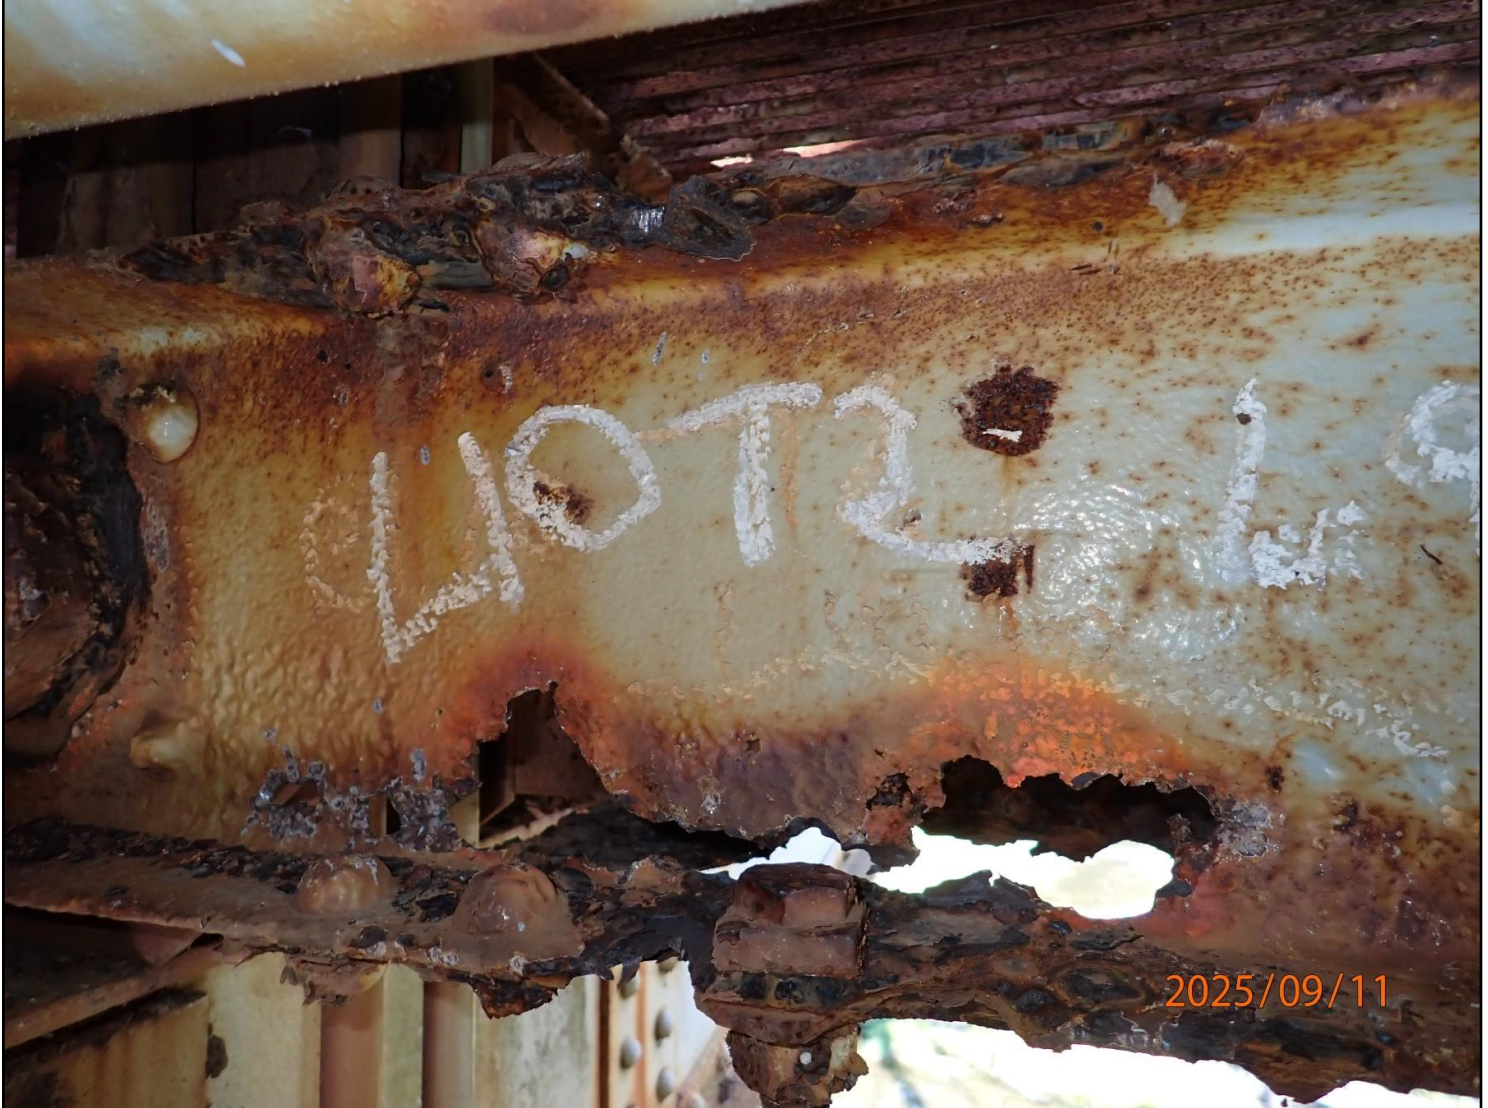
Photo Number: 5

--Left Channel: There are 3 holes in the bottom of the web that measure 10" long x 2.25" high, 5/8" diameter and 1" long x 1/2" high (was two holes that measured 3" long x 1.5" high and 2.5" long x 2" high). The rest of the web exhibits 25% section loss. The top and bottom flanges exhibit holes with up to 75% section loss. (photo 5)

***Attachment Description: Right Truss, L9-L10 at L10, Left Channel, Looking Right***

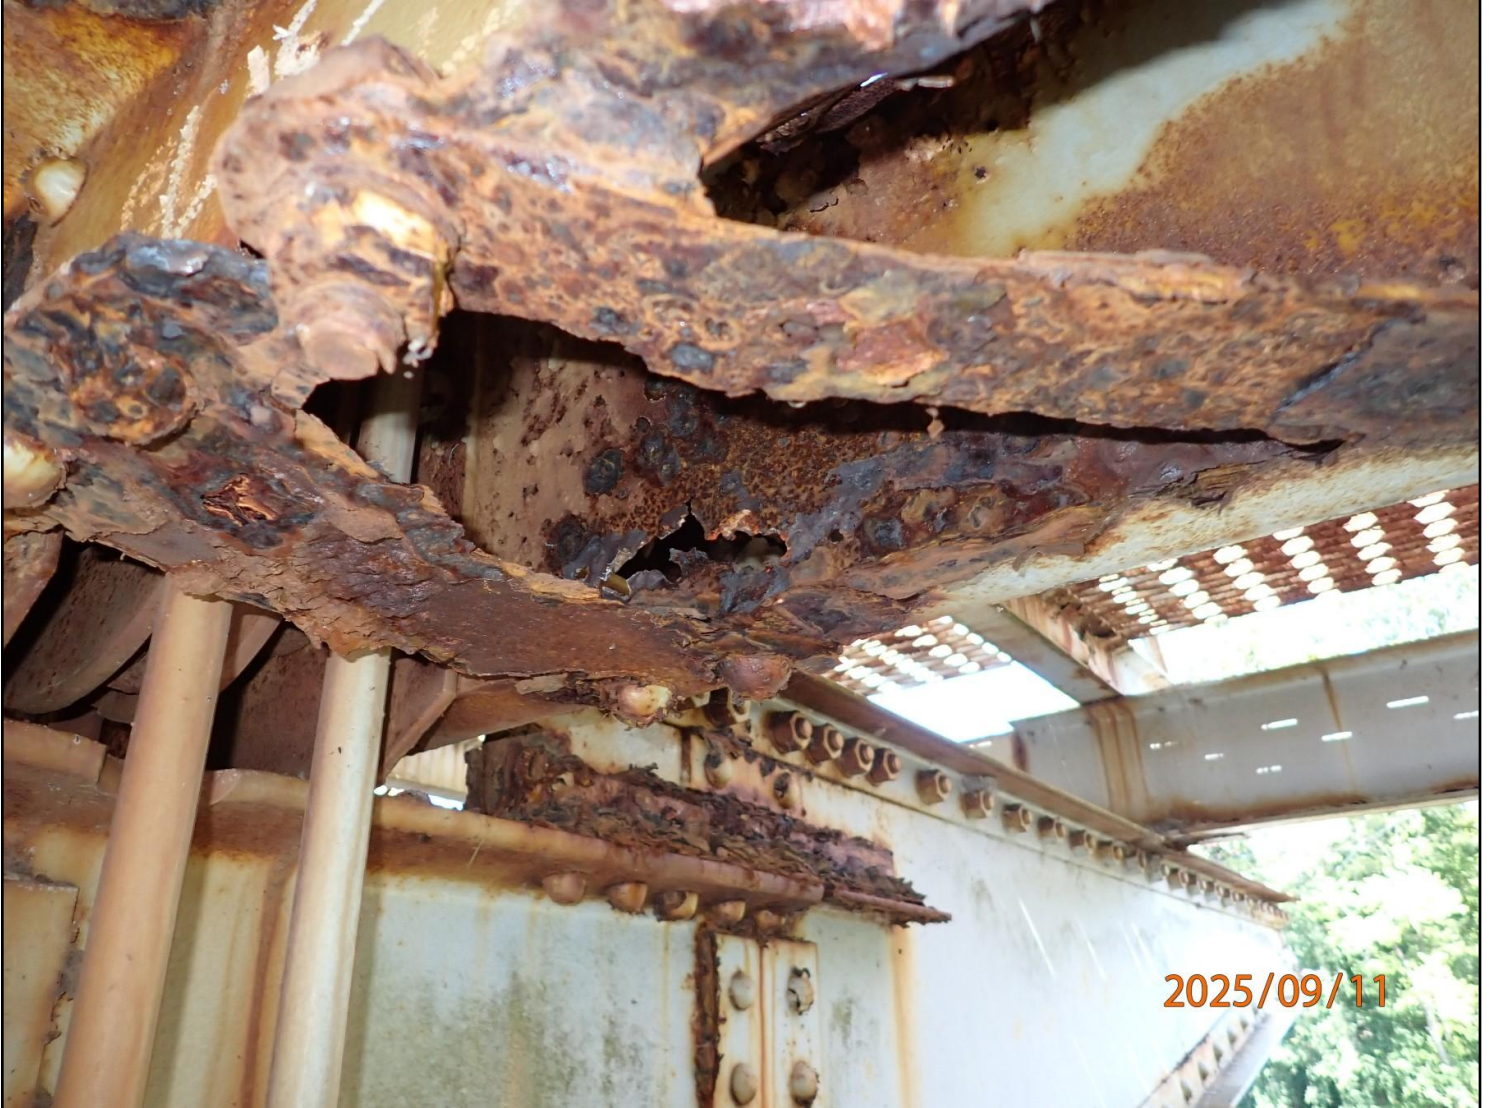
Photo Number: 6

--Right Channel: There is a hole in the bottom of the web that measures 5.5" long x 1.5" high (was 4" long x 1" high). The rest of the web exhibits 25% section loss with the lower half being worse. The top and bottom flanges exhibit up to 50% section loss. (photo 6)

**Attachment Description:** Right Truss, L9-L10 at L10, Looking End Right (close up of right channel)

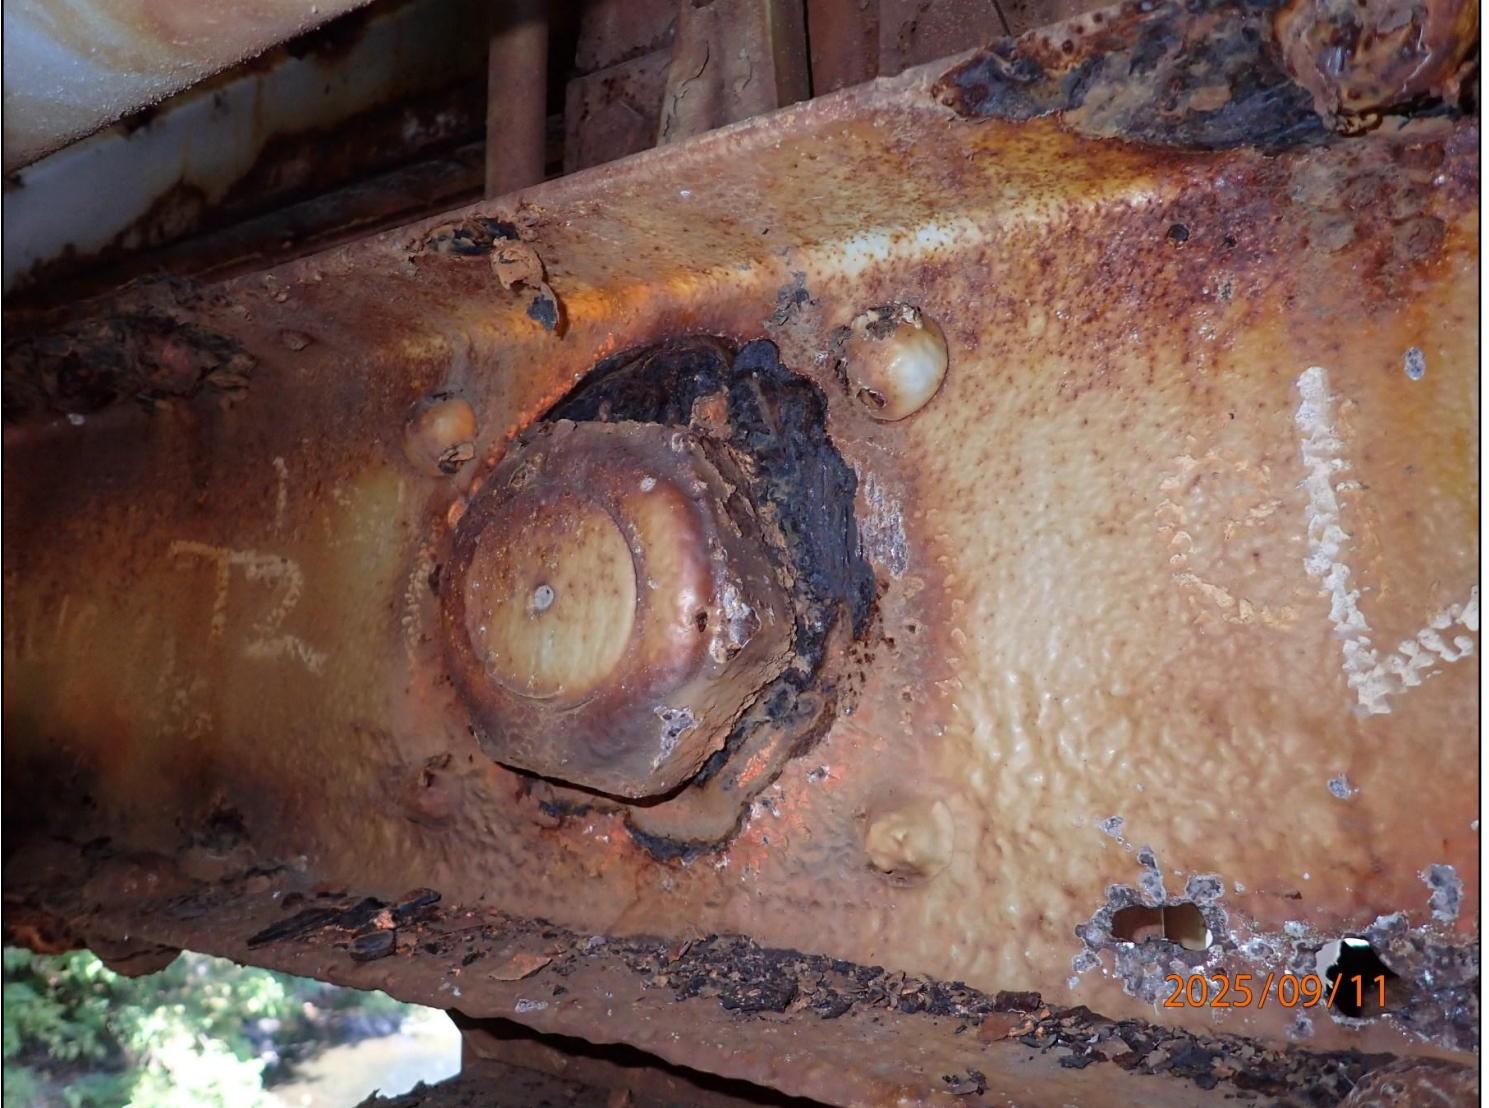
Photo Number: 7

--The Left side channel exhibits approx. 25% section loss for a width of 1" around the pin on the Left side (new). (photo 7)

***Attachment Description: Right Truss, Left Side Channel at L10, Looking Right***

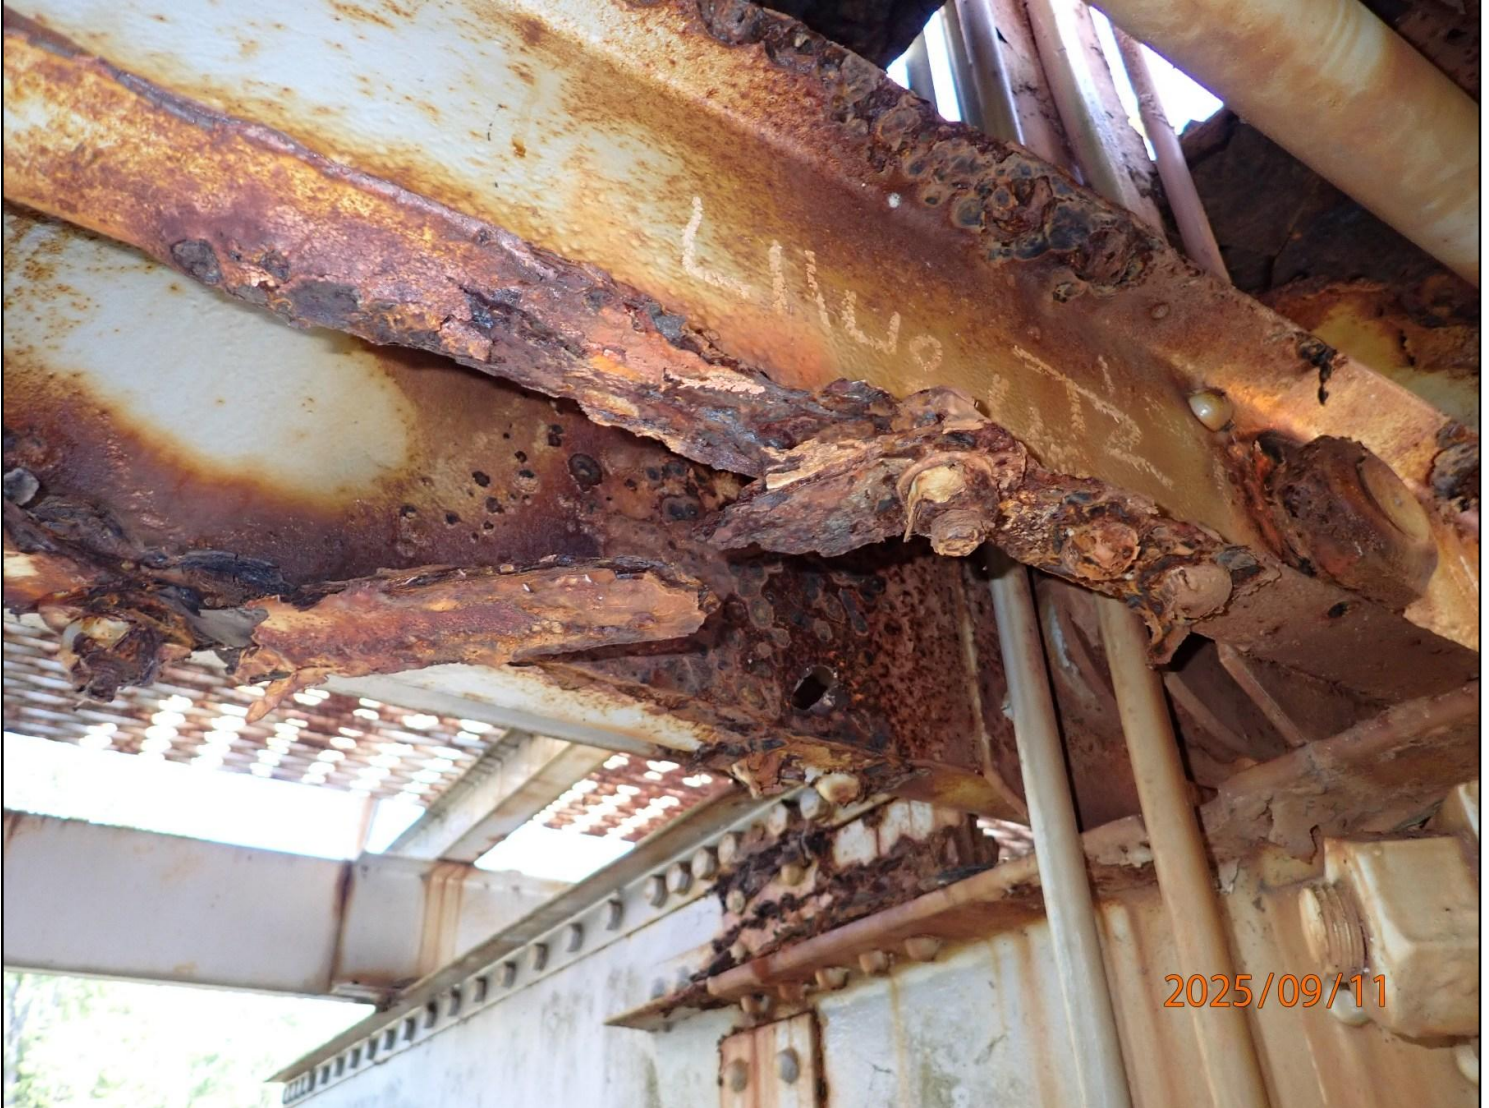
Photo Number: 8

--Right Truss, L10-L11 at L10: The Left and Right channels are heavily corroded with section losses (photo 8). The Right channel has a 1.25" high x 1.5" long hole in the bottom of the web (was 1" x 1"). Overall member section loss is 26% (was 30%). This condition was previously included in YF 8B24T1W030 but has been moved to a separate Yellow Flag for truss members that exhibit section losses not as severe as noted in this flag.

**Attachment Description: Right Truss, L10-L11 at L10, Looking Begin Right**
