# New York State Department of Transportation

## General Bridge Inspection Report

**Inspection Date:** October 06, 2021

**BIN:** 3342250

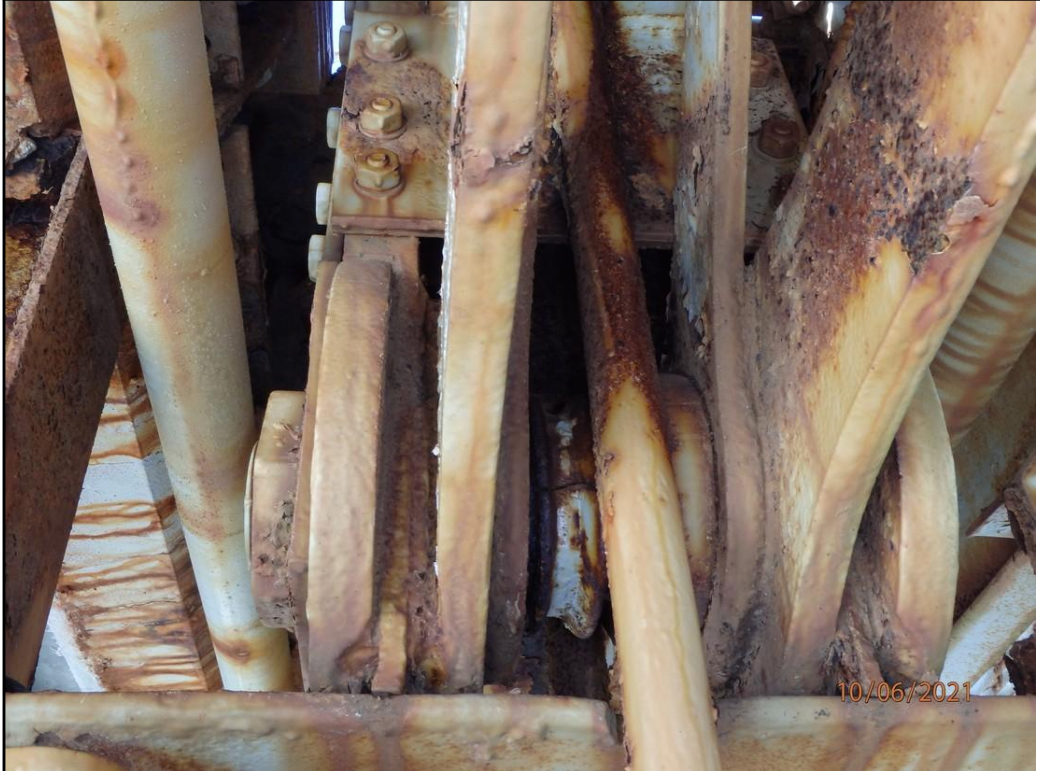
Photo Number: 38

| 2021: Below deck - the original pin assemblies below deck have pack rust between the members (bottom chord, diagonal, vertical members) on both trusses. Due to paint failure the corrosion and rust is now active (Photos 36 & 37). At the Left Truss, L1 (begin side) has a cracked spacer. At the Right Truss, L1 has a cracked spacer (Photo 38). At the Right Truss, L5 (begin face) has a cracked spacer on the left side of the hanger rod (Photo 39). No signs of distress were observed to the assembly at the above locations.<br><br>Above deck, the pins at mid-height have fine rust powder around the pinned connections at M4 and M6 at both left and right trusses and M10 at left truss. This indicates the steel members are grinding against each other (Photos 24 & 40). The upper truss connection pins, at both the left and right trusses, are not completely tightened and the nuts are not fully engaged at U1 and U11 and at the left truss, U7 outboard nut. This is an old and stable condition, no changes from previous inspection (Photos 41 & 42). At the Left Truss, U11 the inside pin collar/spacer is falling out. Pin is in good condition and no movement noted on the pin nuts (Photo 43).<br><br>This hybrid bridge is not able to be load rated with NYSDOT's BrR software. A Level One load rating is strongly recommended to assess the significant deterioration which has occurred since the 1992 rehabilitation. | | | | | | |

**Attachment Description:**  
Right Truss, L1 Begin Face,  
Looking: End

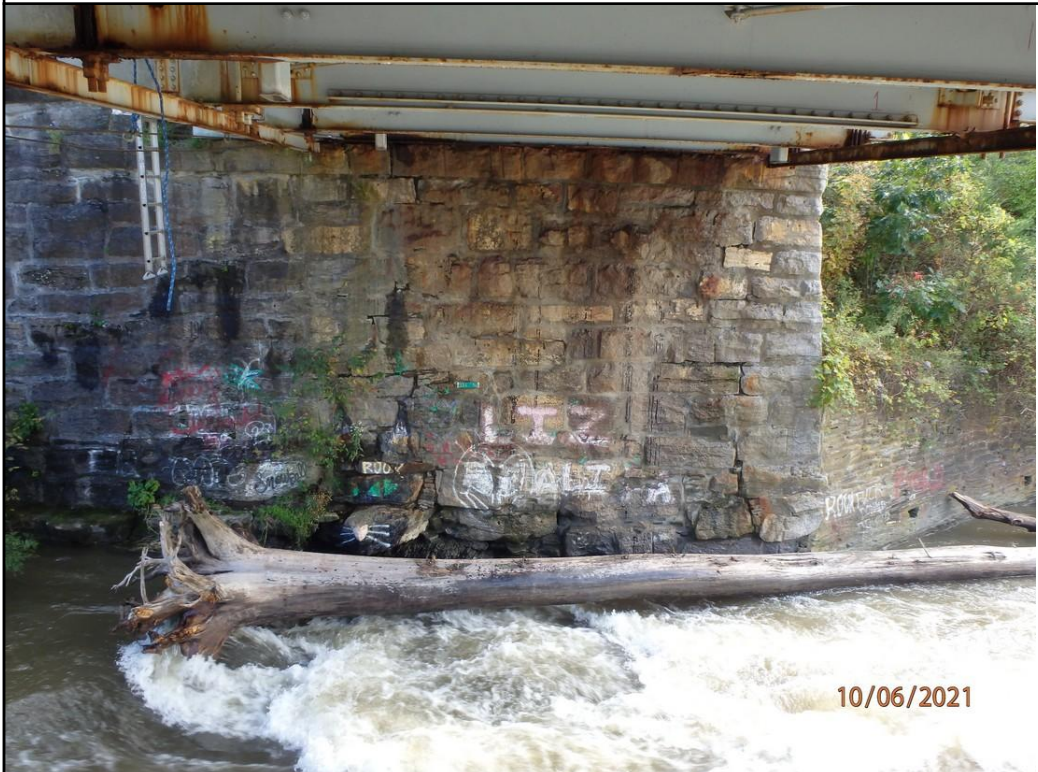
Photo Number: 45

| Span 1: EA217 - Masonry Abutment<br>Condition State 3 Note<br><b>Referenced Photo(s):</b> 45<br><b>Referenced Sketch(es):</b> None | TQ | CS-1 | CS-2 | CS-3 | CS-4 | CS-5 |
| 2021: In general, the masonry abutment is in good condition except for the bottom half. The bottom half of the abutment is missing mortar and has active efflorescence staining /leakage. In addition, there are several cracked stones. Upper portion of the abutment is in better condition. Overall the abutment stem is stable. | | | | | | |

**Attachment Description:**  
End Abutment Stem,  
Looking: End

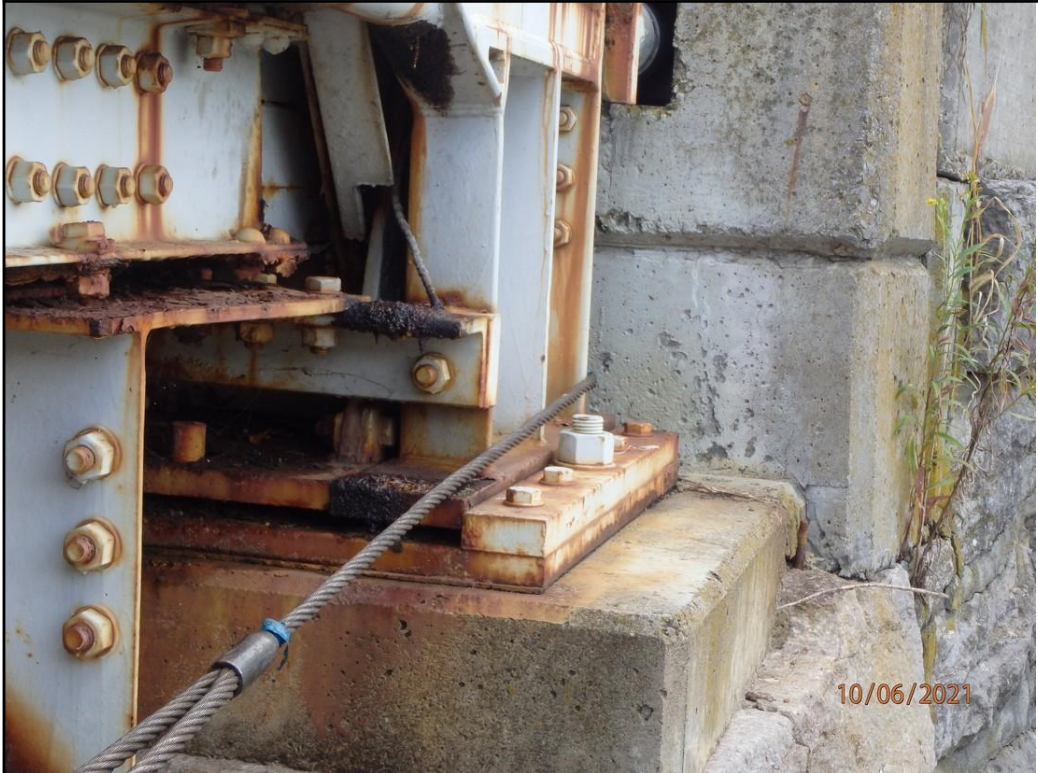
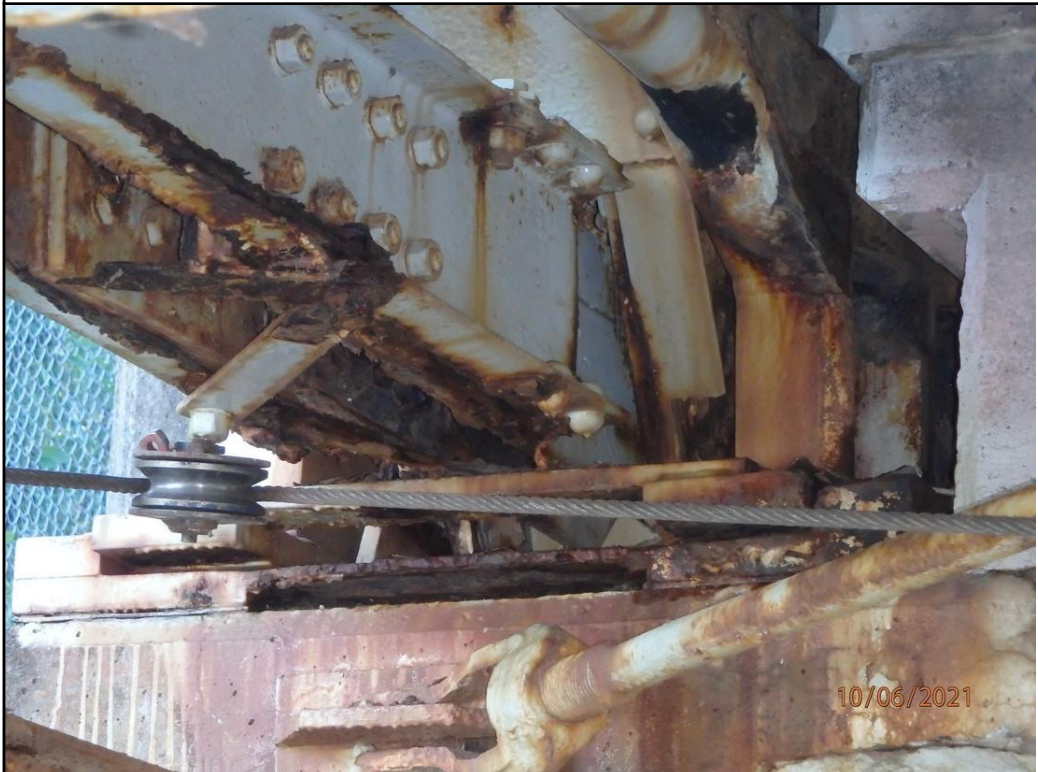
| <b>Condition State 3 Note</b><br><i>Referenced Photo(s):</i> 48, 49<br><i>Referenced Sketch(es):</i> None | | | | | | |
| 2021: The paint system is starting to fail around the bottom of the bearing with rust staining/bleeding and the start of minor corrosion. | | | | | | |

**Attachment Description:**  
Left Truss End Abutment  
Bearing, Looking: End Left

**Attachment Description:**  
Right Truss End Abutment  
Bearing, Looking: End

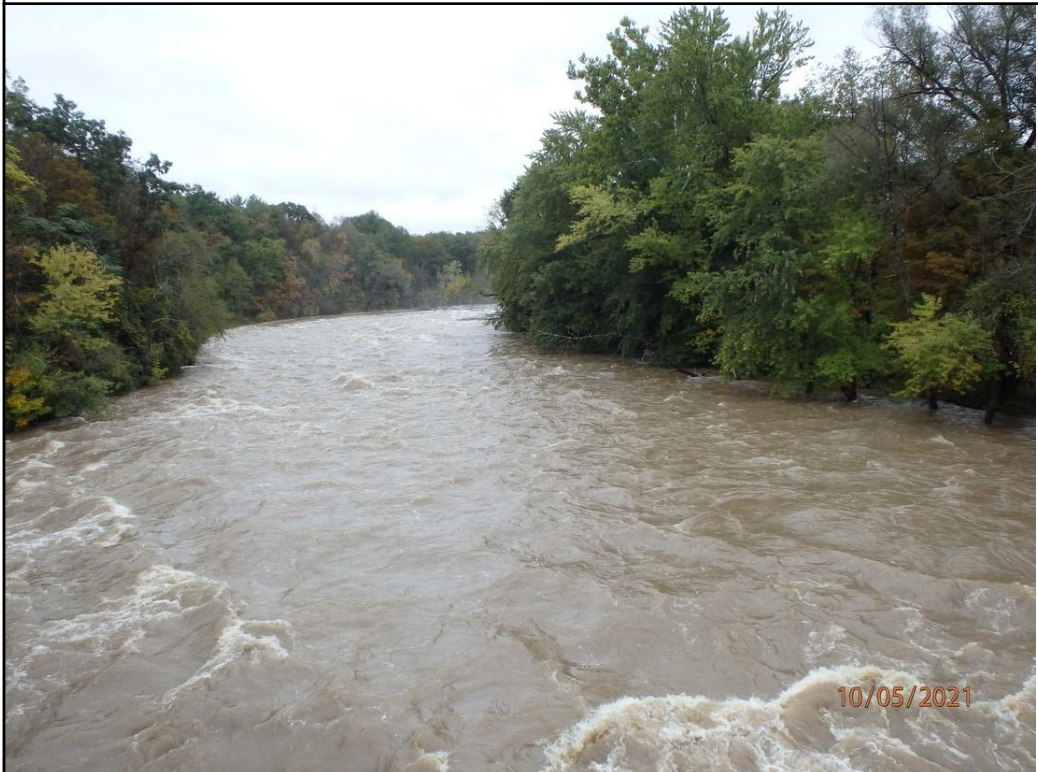
| 2021: See Stream Hydraulics Defect History Sketch for details. | | | | | | |

**Attachment Description:**  
Right Channel, Looking:  
Upstream/End Right

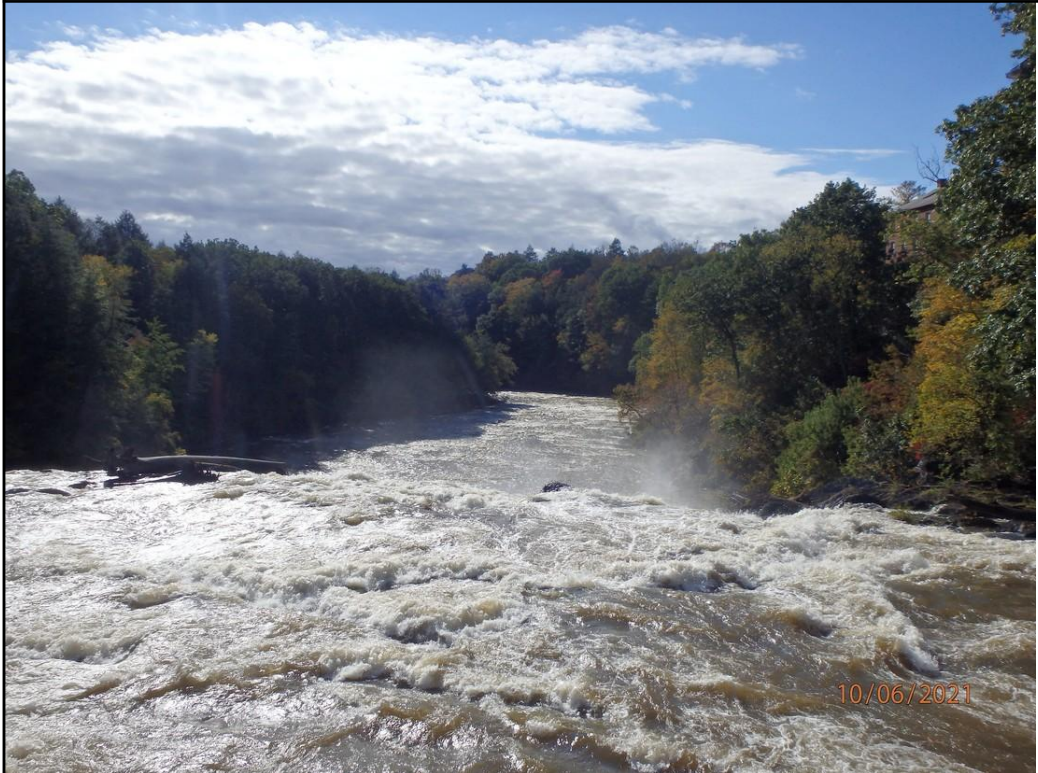
**Attachment Description:**  
Left Channel, Looking:  
Downstream/Left

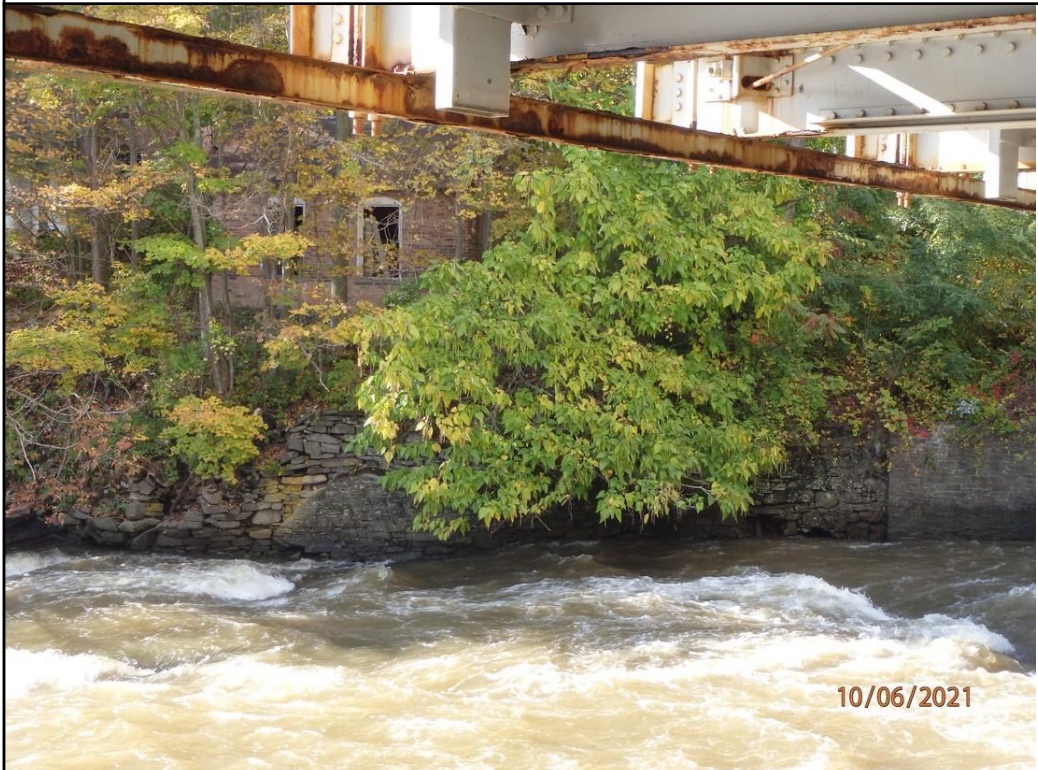
**Attachment Description:**  
End Left Retaining  
Wall/Bank, Looking: End  
Left

Bank Protection: At the end left, the retaining wall (not considered the wingwall) which is made up of stone masonry, has missing stones near the water elevation that is starting to fail. The wall still retains the embankment. The remaining bank protection is in good condition (Photo 54). Rates CS3.

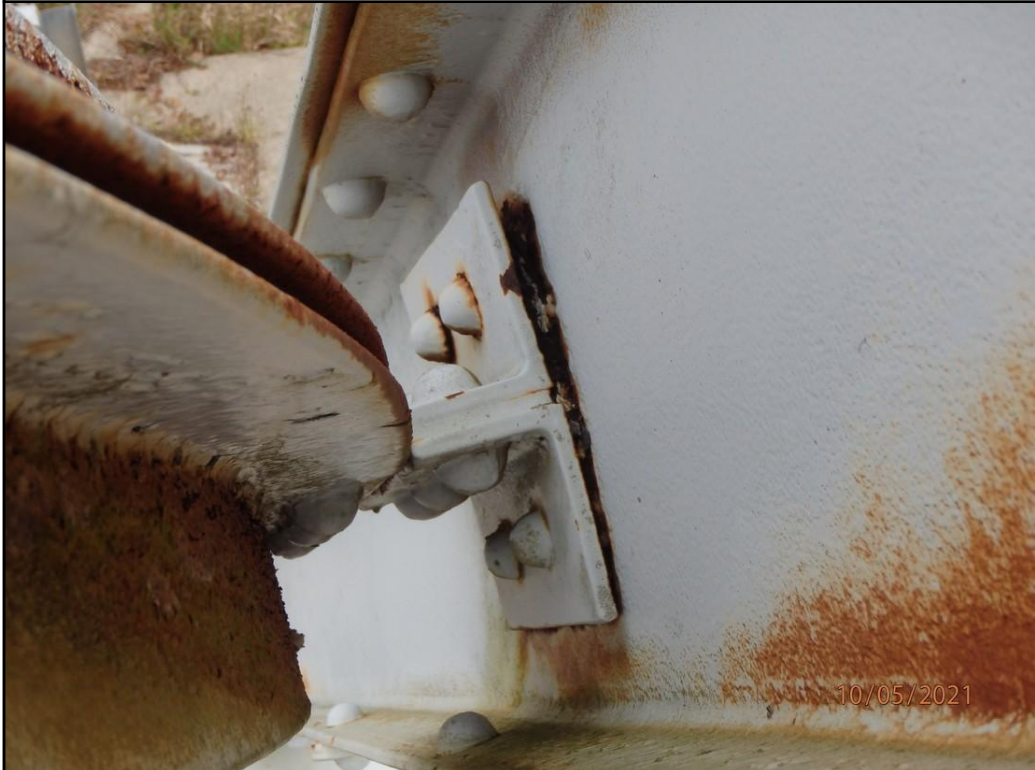
| 2021: Above deck, the upper wind bracing angles at panels 1 and 2 are bent. No change from previous inspection. The angle connecting the end portal to the left and right truss/arch at U11 and right truss/arch at U1 is starting to corrode causing small perforations (Photos 56 and 57). The angle connecting the end portal to the left and right truss/arch at U1 and right truss/arch at U11 has pack rust of up to 1" thick (Photos 23 & 58). The rivets adjacent to the pack rust appears to be solid and the portal is sturdy when pushed by hand with no movement noticed. The cotter pin for the connection of the sway bracing is not fully inserted at U3, left side and U5 right side. No change from previous inspection (Photos 59 & 60).<br><br>Below deck, the lower lateral bracing connected to the original floorbeams pass through cutouts in the web of the newer floorbeams. The connection of the lateral bracing to the original floorbeams have paint failure with corrosion. The worse location is at floorbeam FB6 end right side (Photo 61). On the original parts of the bottom chord, the lacing bars are corroded. No significant changes.<br><br>Steel Shield Plates: There are steel plates that cover the bottom chords (both left and right) at the top of the roadway level. These steel plates are considered a secondary member. These plates are starting to corrode (with the start of perforations). On the underside the bolts that connect the steel plate to the deck are corroded up to 85% (Photos 62 & 63). | | | | | | |

**Attachment Description:**  
Left Truss Begin Portal  
(L0U1) at Begin Connection  
Angle Pack Rust, Looking:  
Begin Left

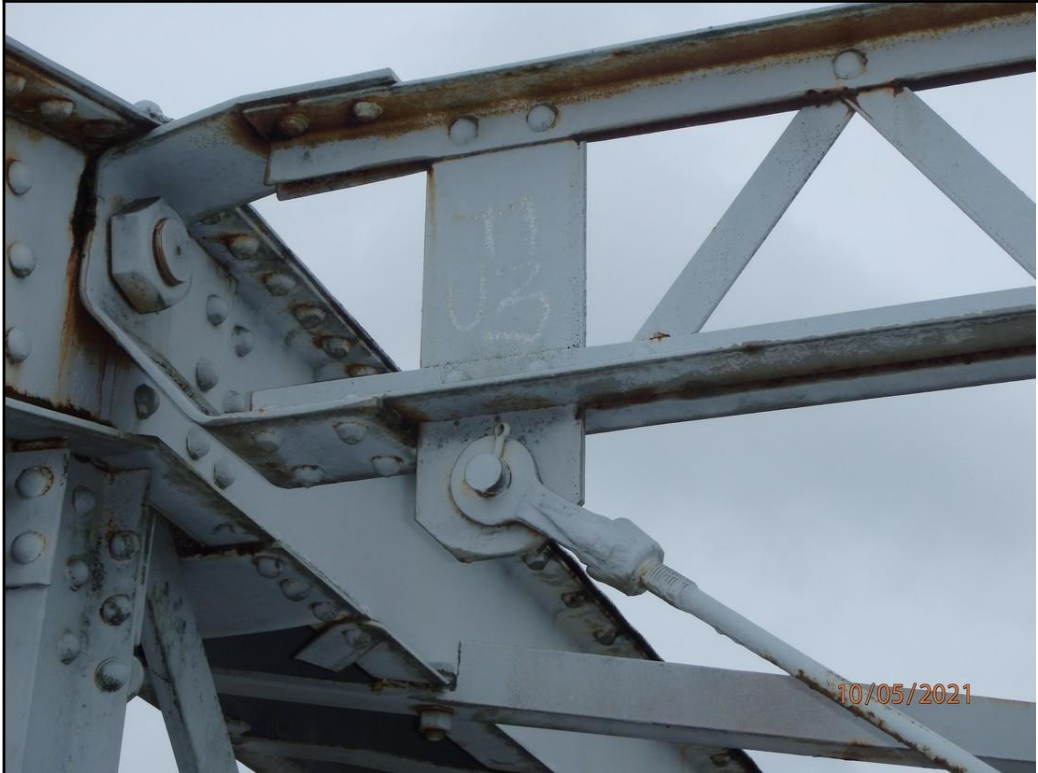
**Attachment Description:**  
Left Truss at U3 Begin Face  
– Cotter Pin for Sway  
Bracing, Looking: End Left

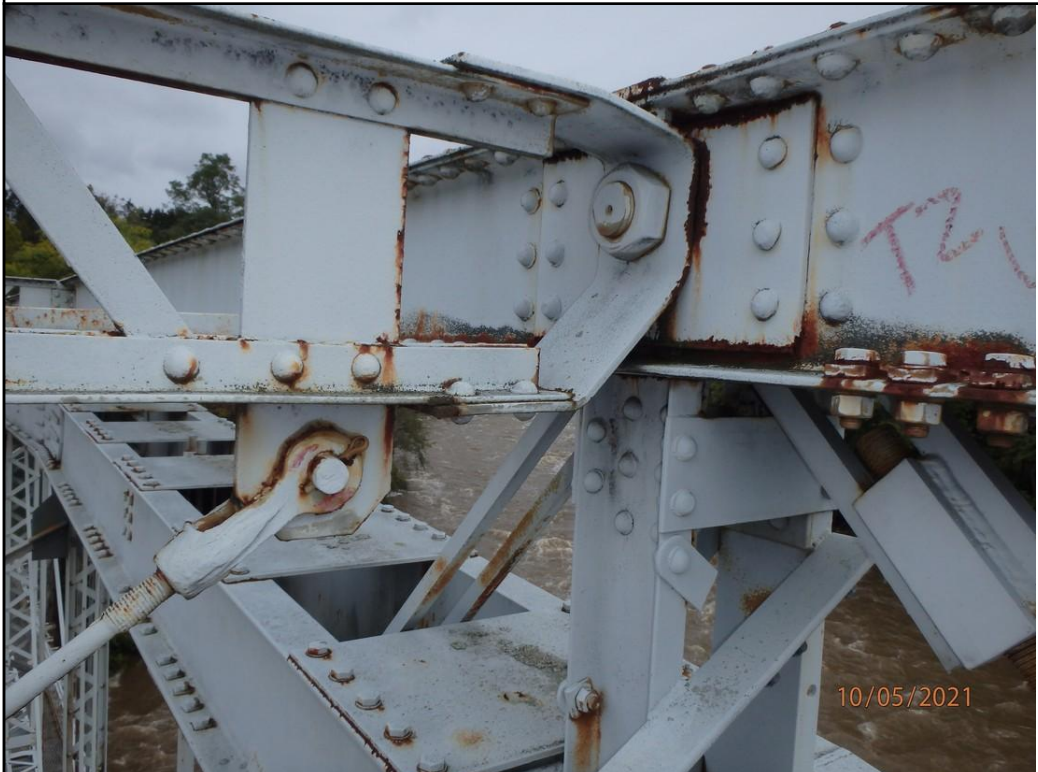
**Attachment Description:**  
Right Truss at U5 Begin  
Face – Cotter Pin for Sway  
Bracing, Looking: End Right

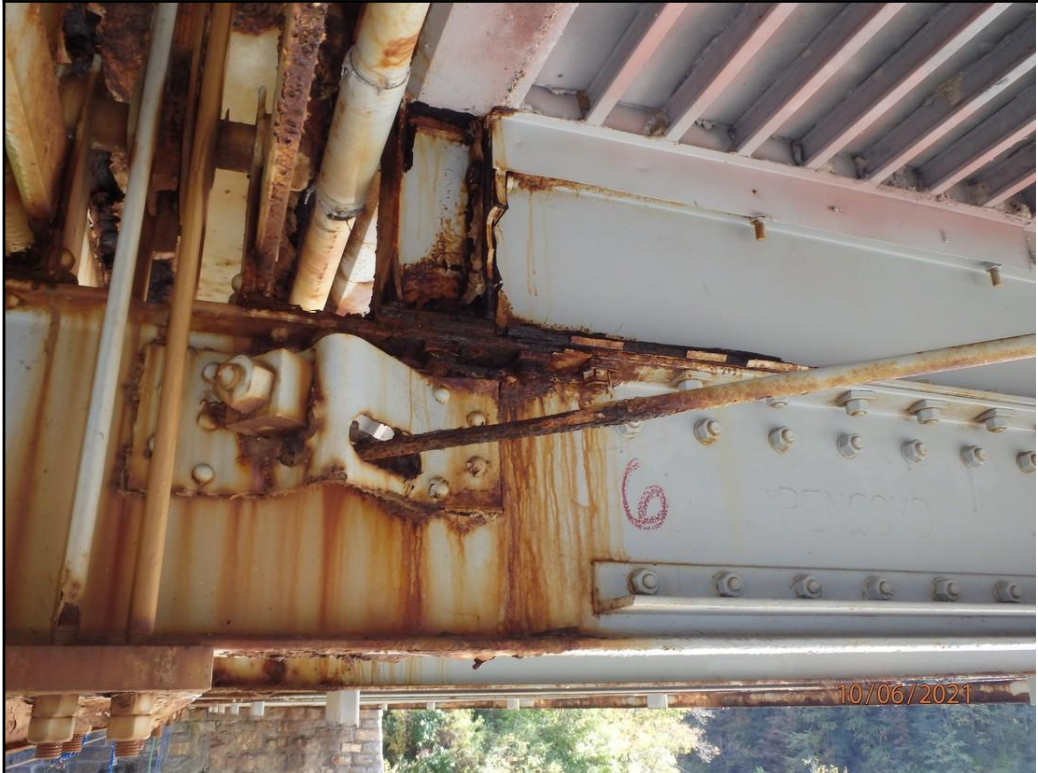
**Attachment Description:**  
Right Truss at End Face of  
Floorbeam FB6 – Lateral  
Bracing Rod, Looking:  
Begin Left

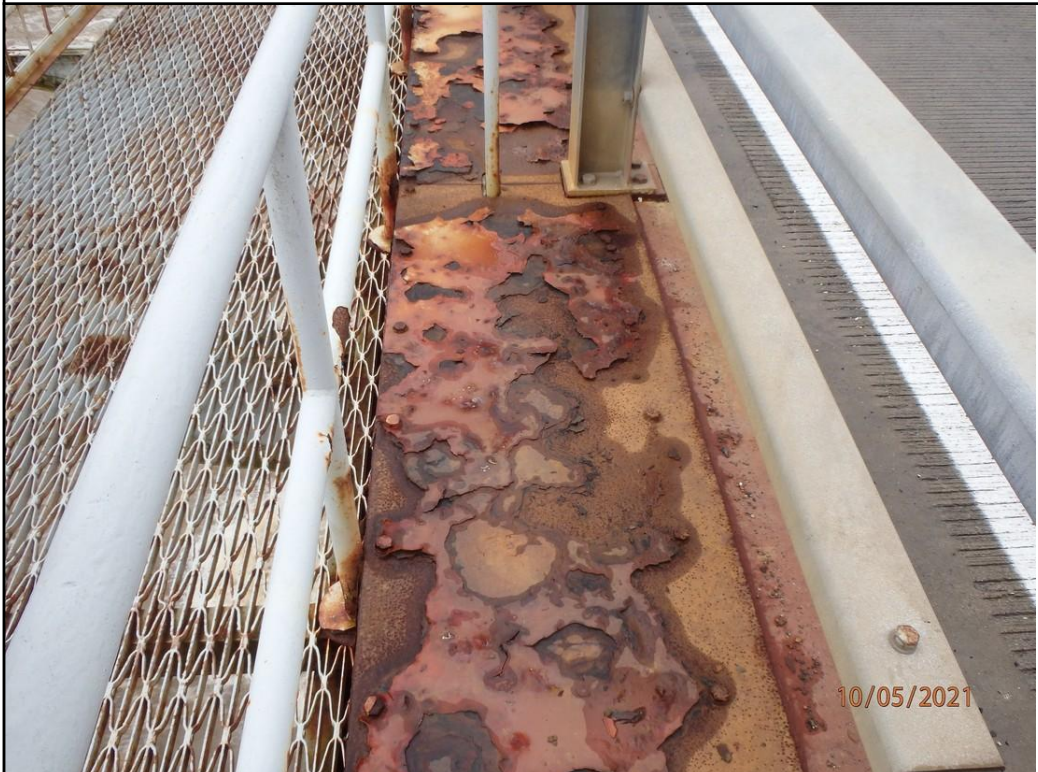
**Attachment Description:**  
Right Truss Steel Shield  
Plate between Floorbeam  
FB7.5 and 8, Looking:  
Down & Begin

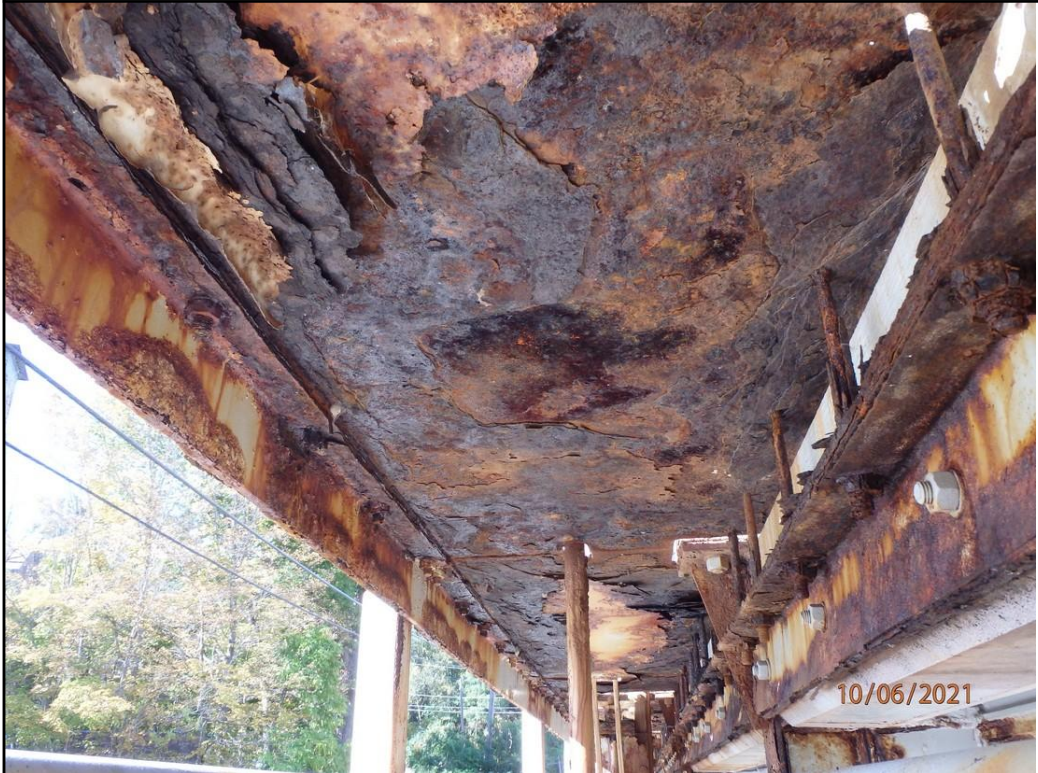
**Attachment Description:**  
Left Truss Steel Shield  
between Floorbeam FB4  
and 4.5, Looking: Up & End

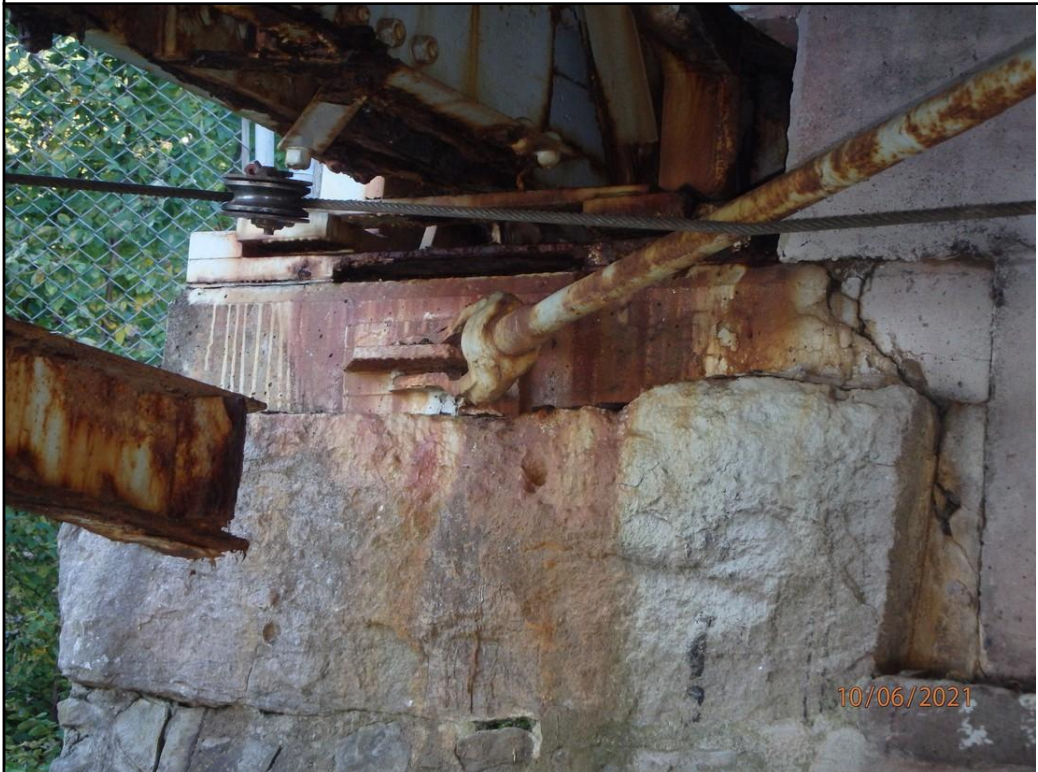
| 2021: Both pedestals have cracks full height x 1/8" W on the inboard sides of the trusses. No change since last inspection. | | | | | | |

**Attachment Description:**  
Left Truss End Abutment  
Pedestal, Looking: End Left

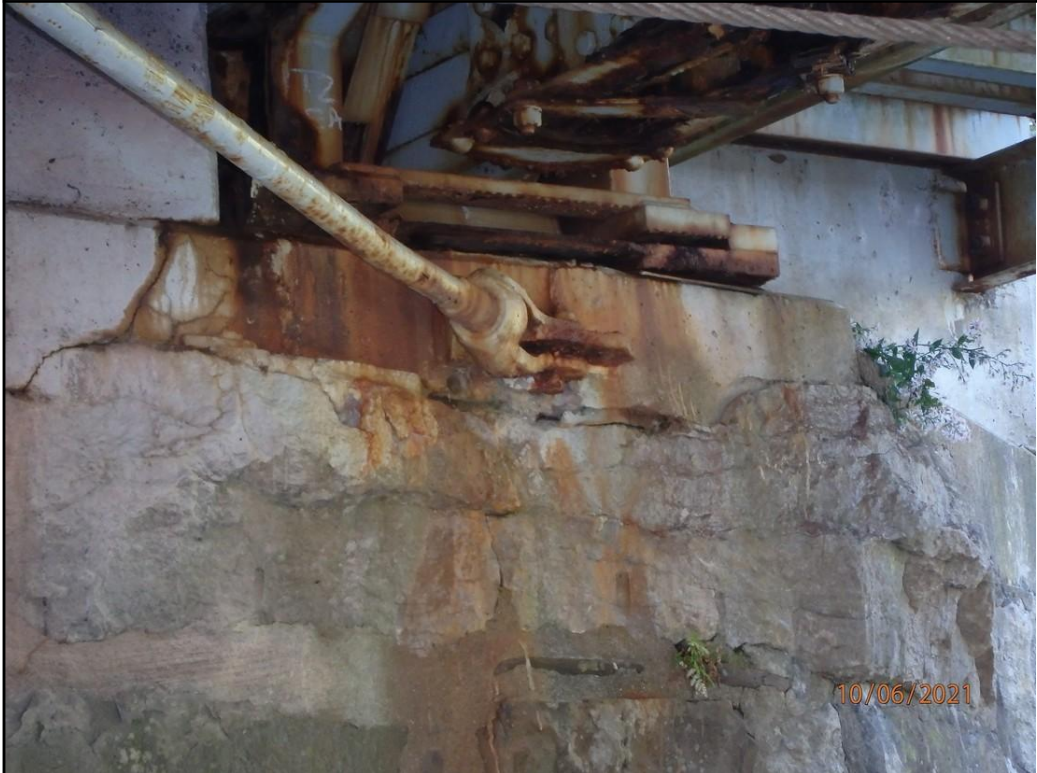
**Attachment Description:**  
Right Truss End Abutment  
Pedestal, Looking: End  
Right

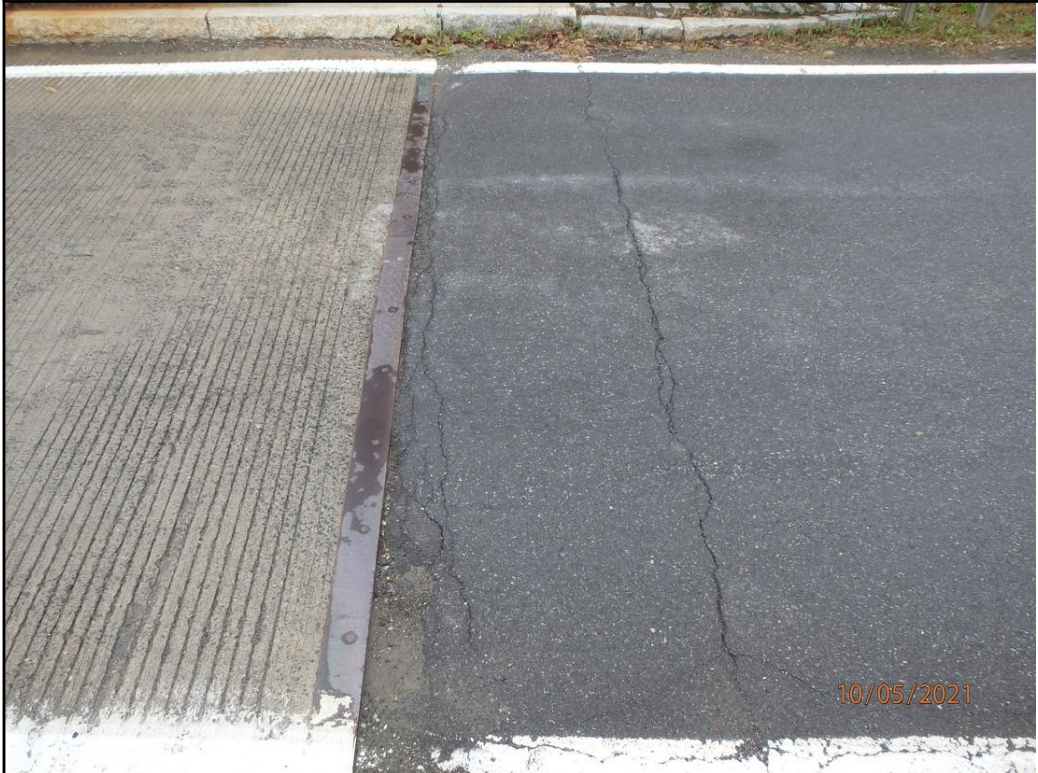
At the end approach the asphalt is cracked and unraveling at the bridge interface (Photo 67). In addition, there is a full width crack up to 1/4" W approximately 2' from the bridge deck.

**Attachment Description:**  
End Approach, Looking:  
Left

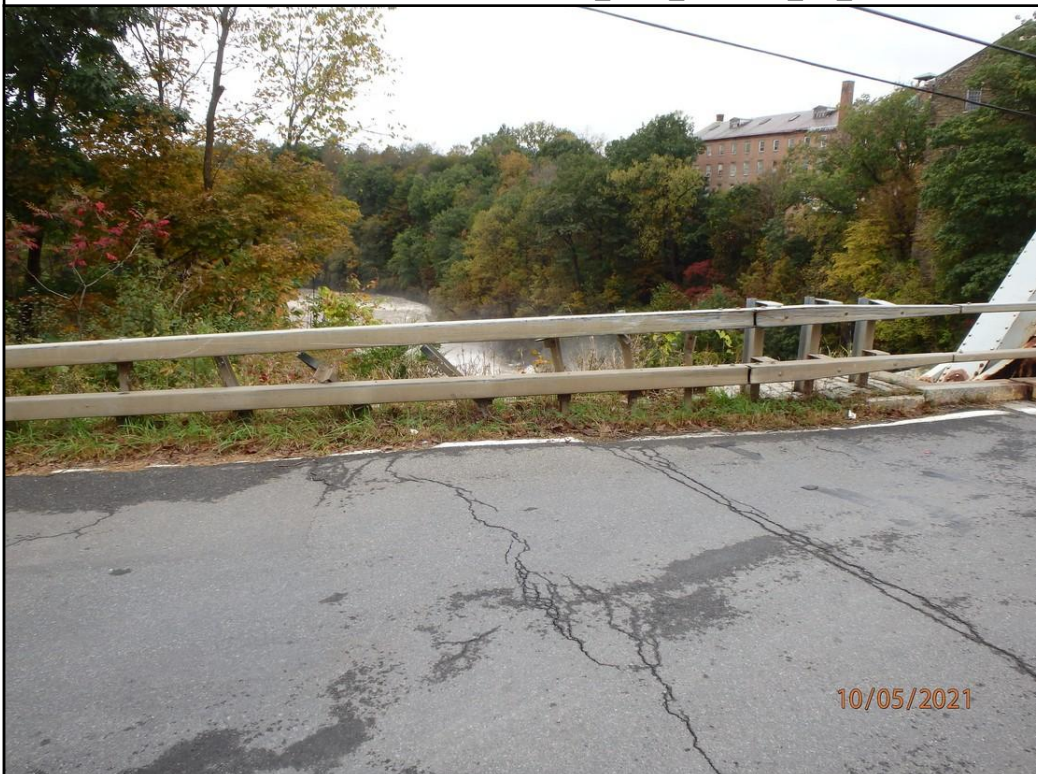
2021: At the begin left there is impact damage to the approach guide railing (Photo 68). There are 5 posts that are bent and disconnected. No change since previous inspection.

**Attachment Description:**  
Begin Left Approach  
Railing, Looking: Left

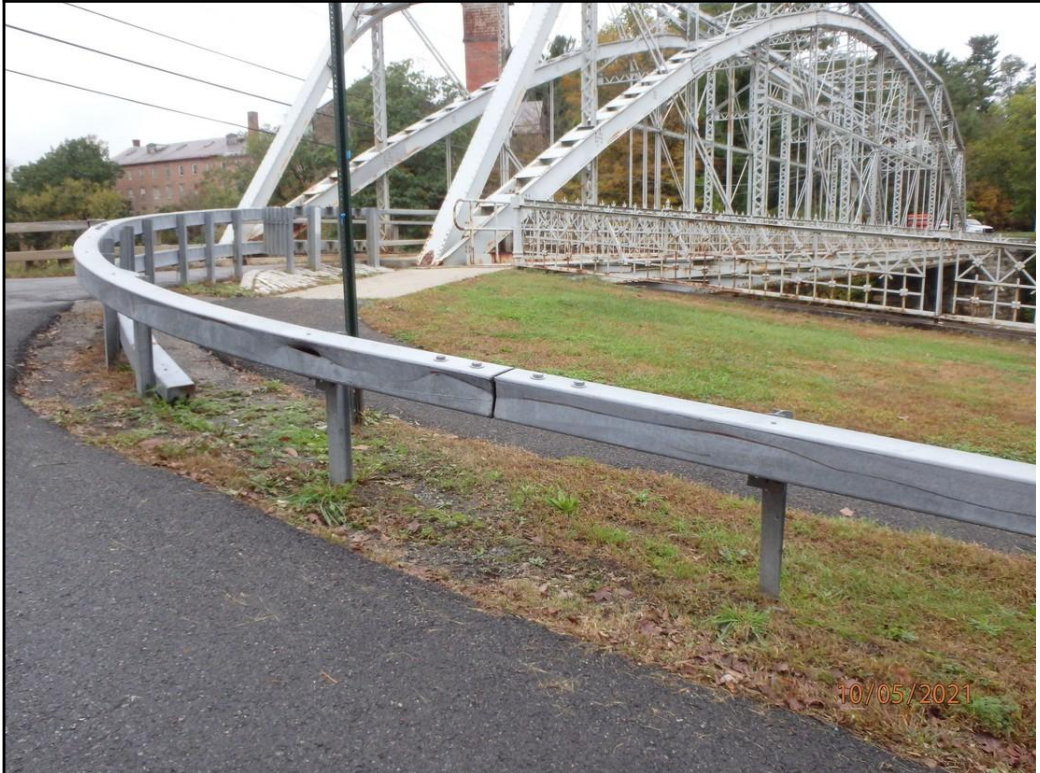
The begin right railing has scrapes due to the tight turn onto the bridge (Photo 69). The posts are in good condition.

**Attachment Description:**  
Begin Right Approach  
Railing, Looking: End Left

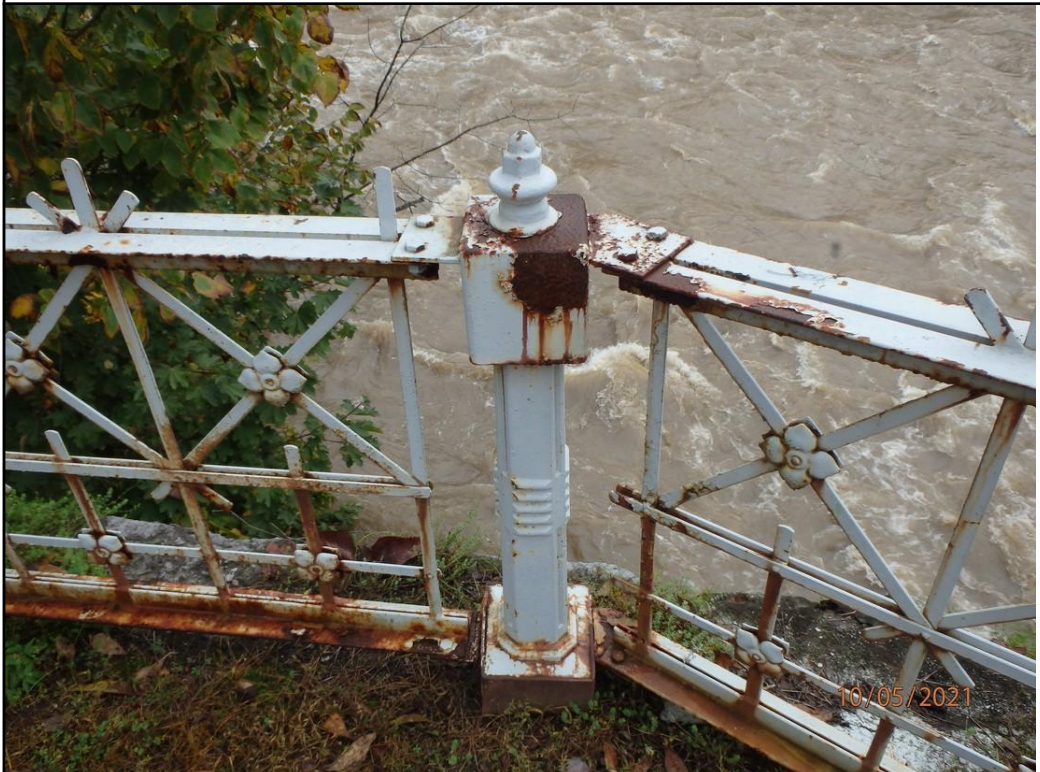
The end right sidewalk railing (near the bridge) has a broken weld at the post and the bottom part of the railing is disconnected and loose. No safety flag warranted since the railing is still functional and this bridge receives little pedestrian traffic (Photo 70).

**Attachment Description:**  
End Right Approach  
Sidewalk Railing, Looking:  
Right
