# New York State Department of Transportation

## General Bridge Inspection Report

**Inspection Date:** October 06, 2021

**BIN:** 3342250

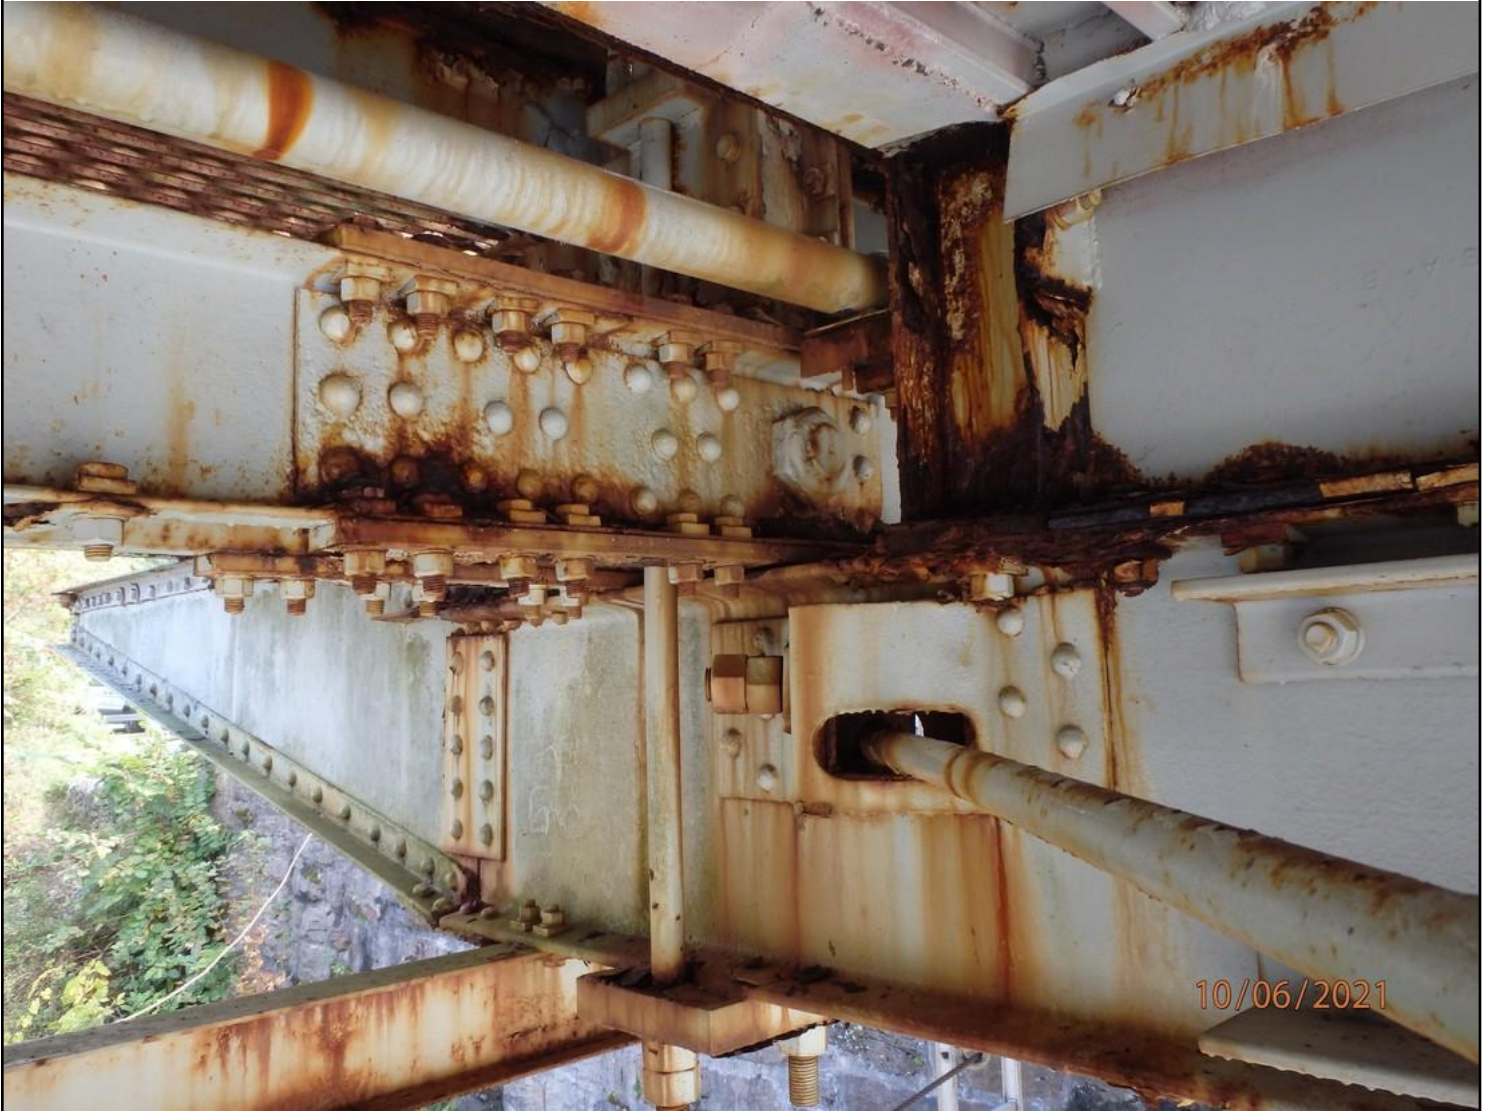
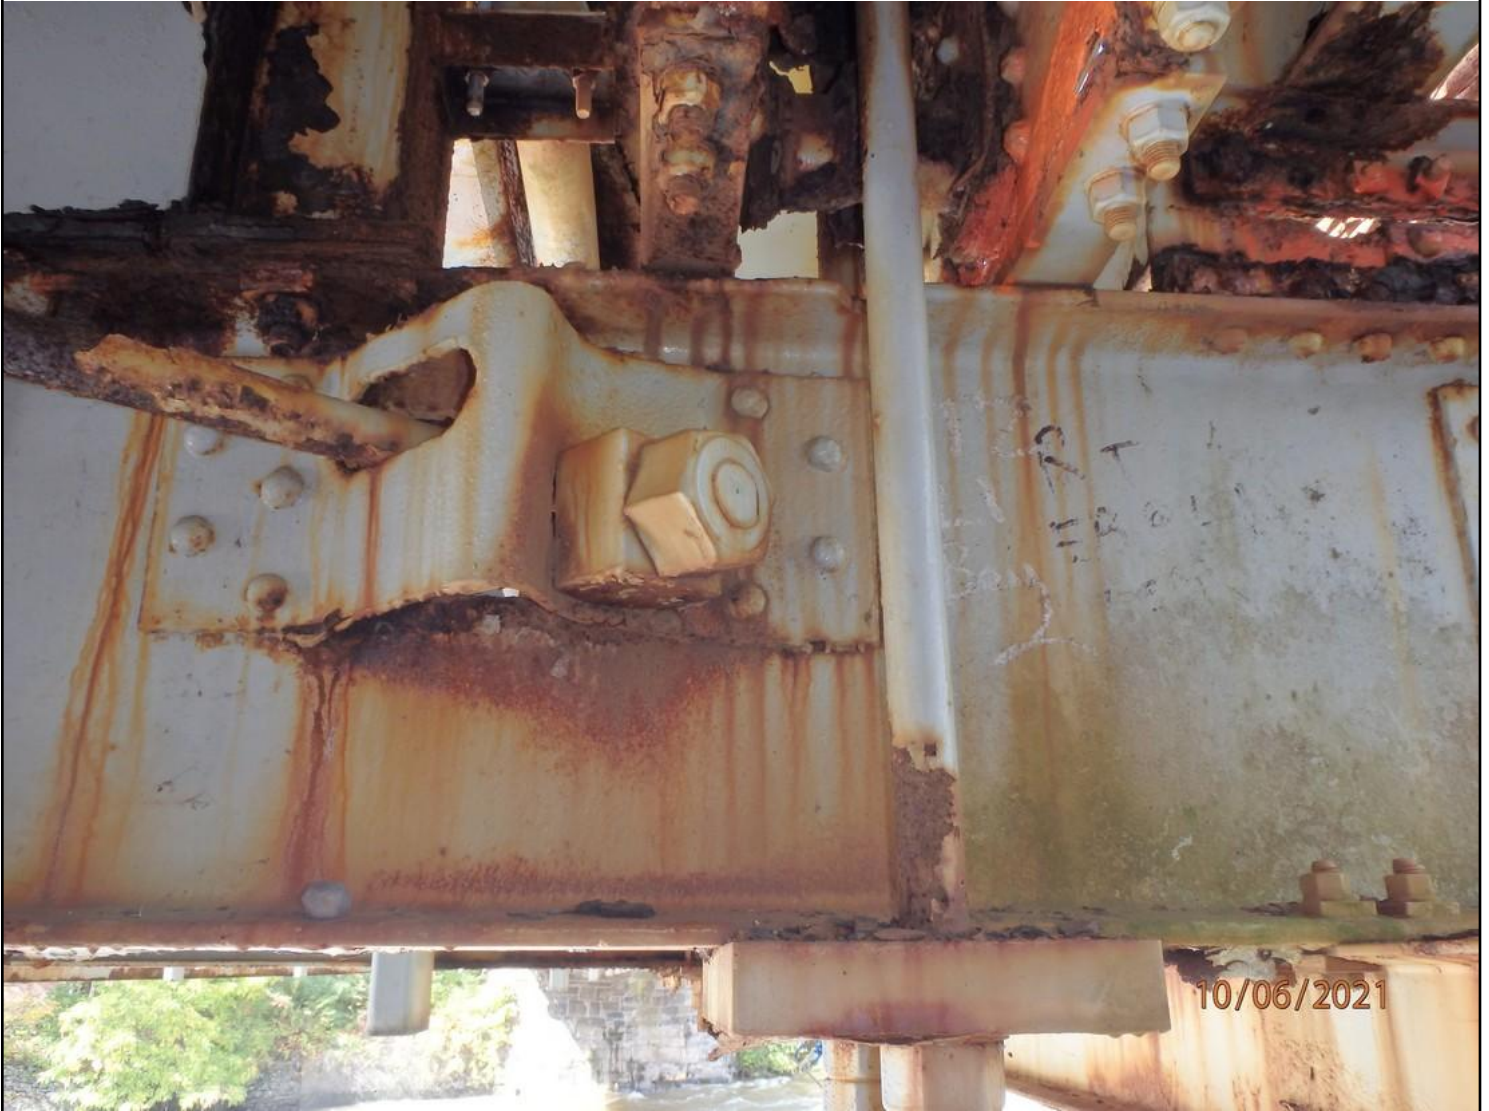
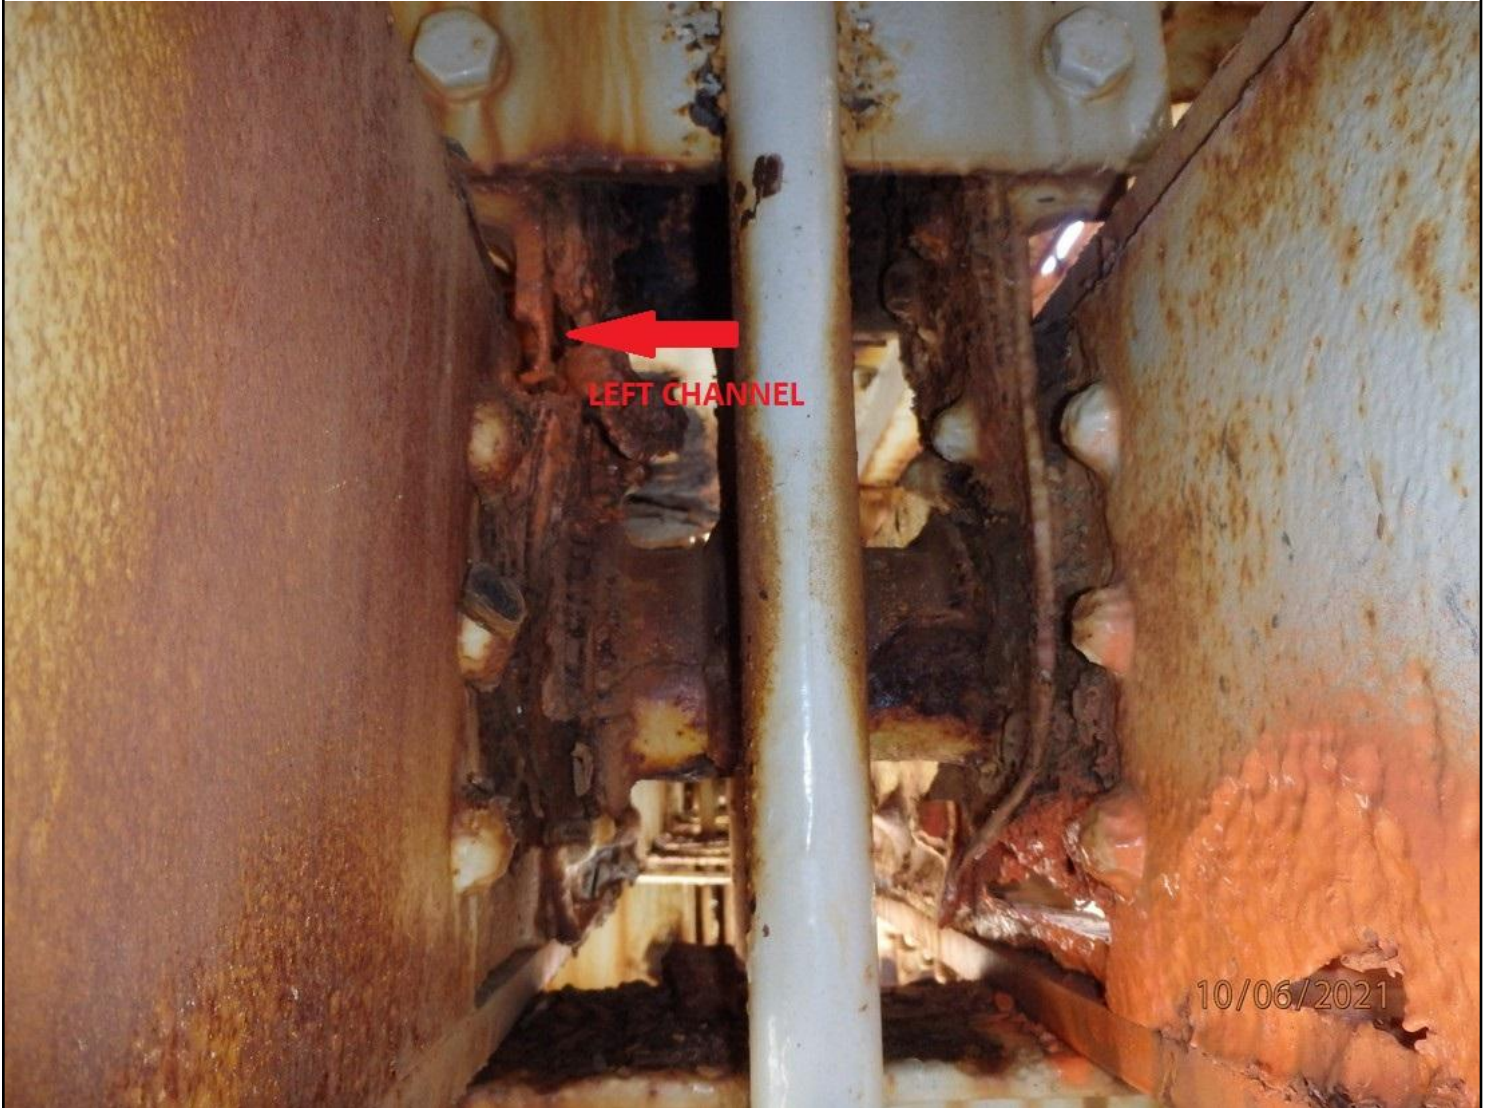
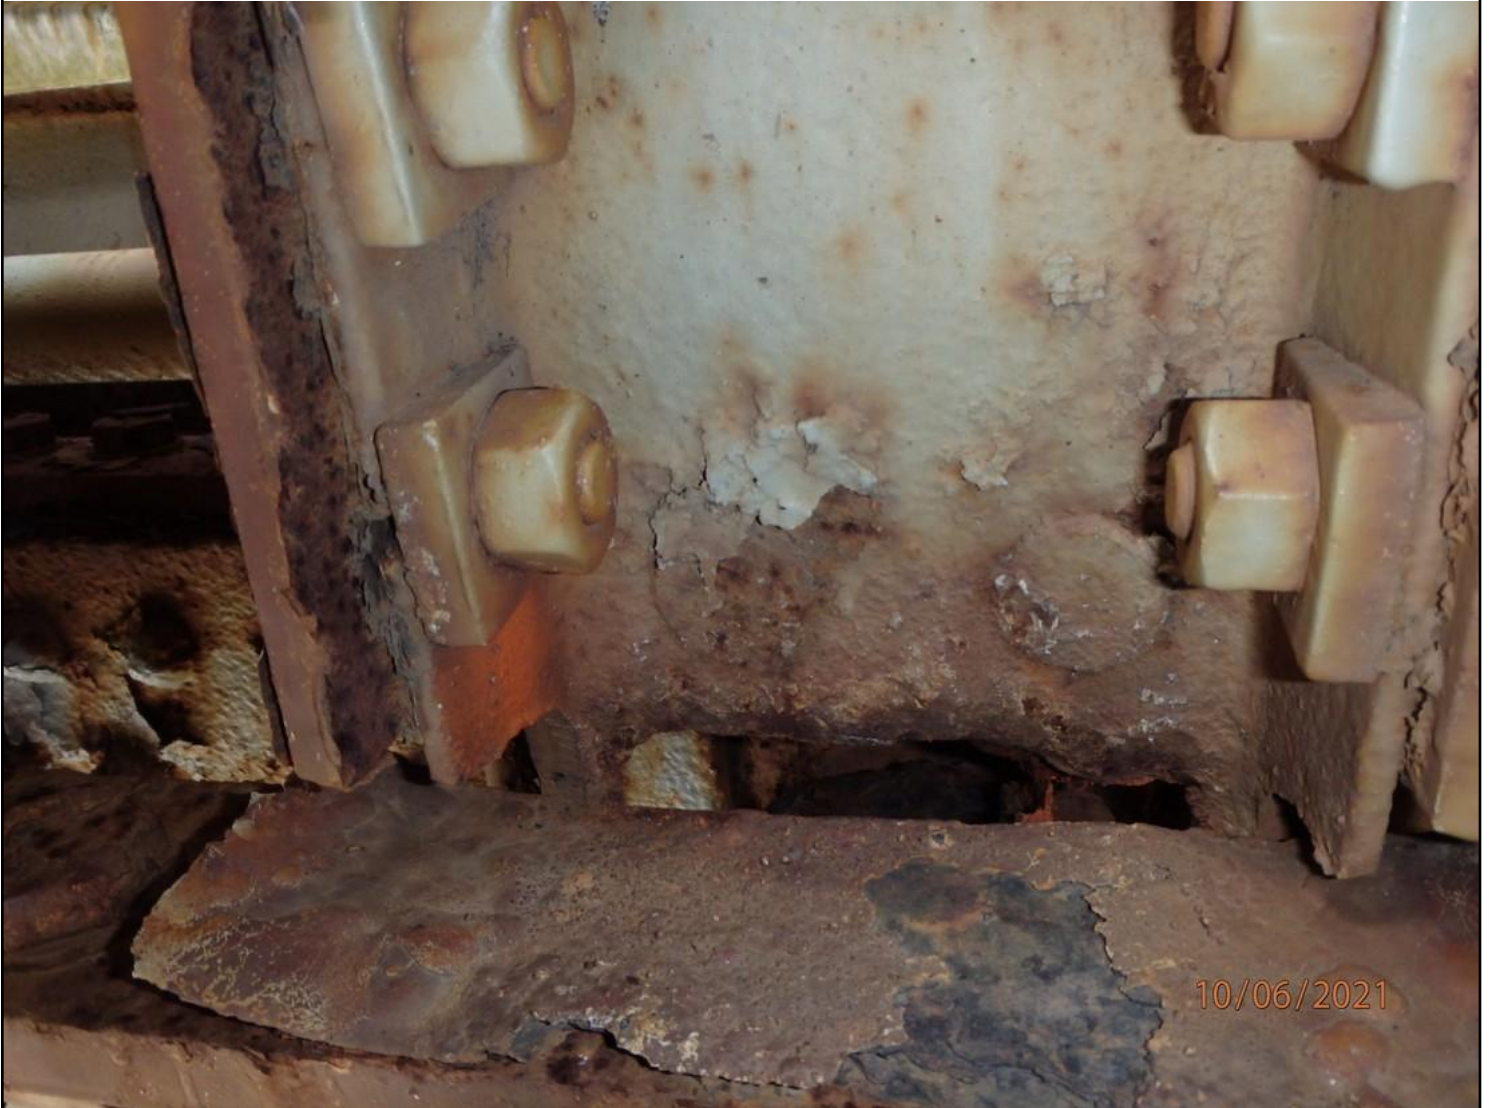
At the right truss at L1 (Floorbeam FB1), the inboard (Left) channel for L1U1 at L1 has perforation to the channel web that is 5" L x 1.5" H and is located above the pin and at the top flange of the bottom chord. The channel at this location has the flanges cut away to fit around the top of the bottom chord member. The web section loss at this location (Left channel) has over 90% section loss. The right channel is in better condition. Overall, the section loss to this member is over 50% (no significant changes since last inspection in 2020) (Photos 2 to 5).

A Yellow flag is reissued since the existing pin connections have been retrofitted with two 1.5" diameter rods that are bolted to the floorbeam and to the existing vertical members above the floorbeams. The rods at the right truss (T1) have minor section losses at this time (approximately 15%). At this time no signs of distress were observed.

This hybrid bridge is not able to be load rated with NYSDOT's BrR software. A Level One load rating is strongly recommended to assess the significant deterioration which has occurred since the 1992 rehab.

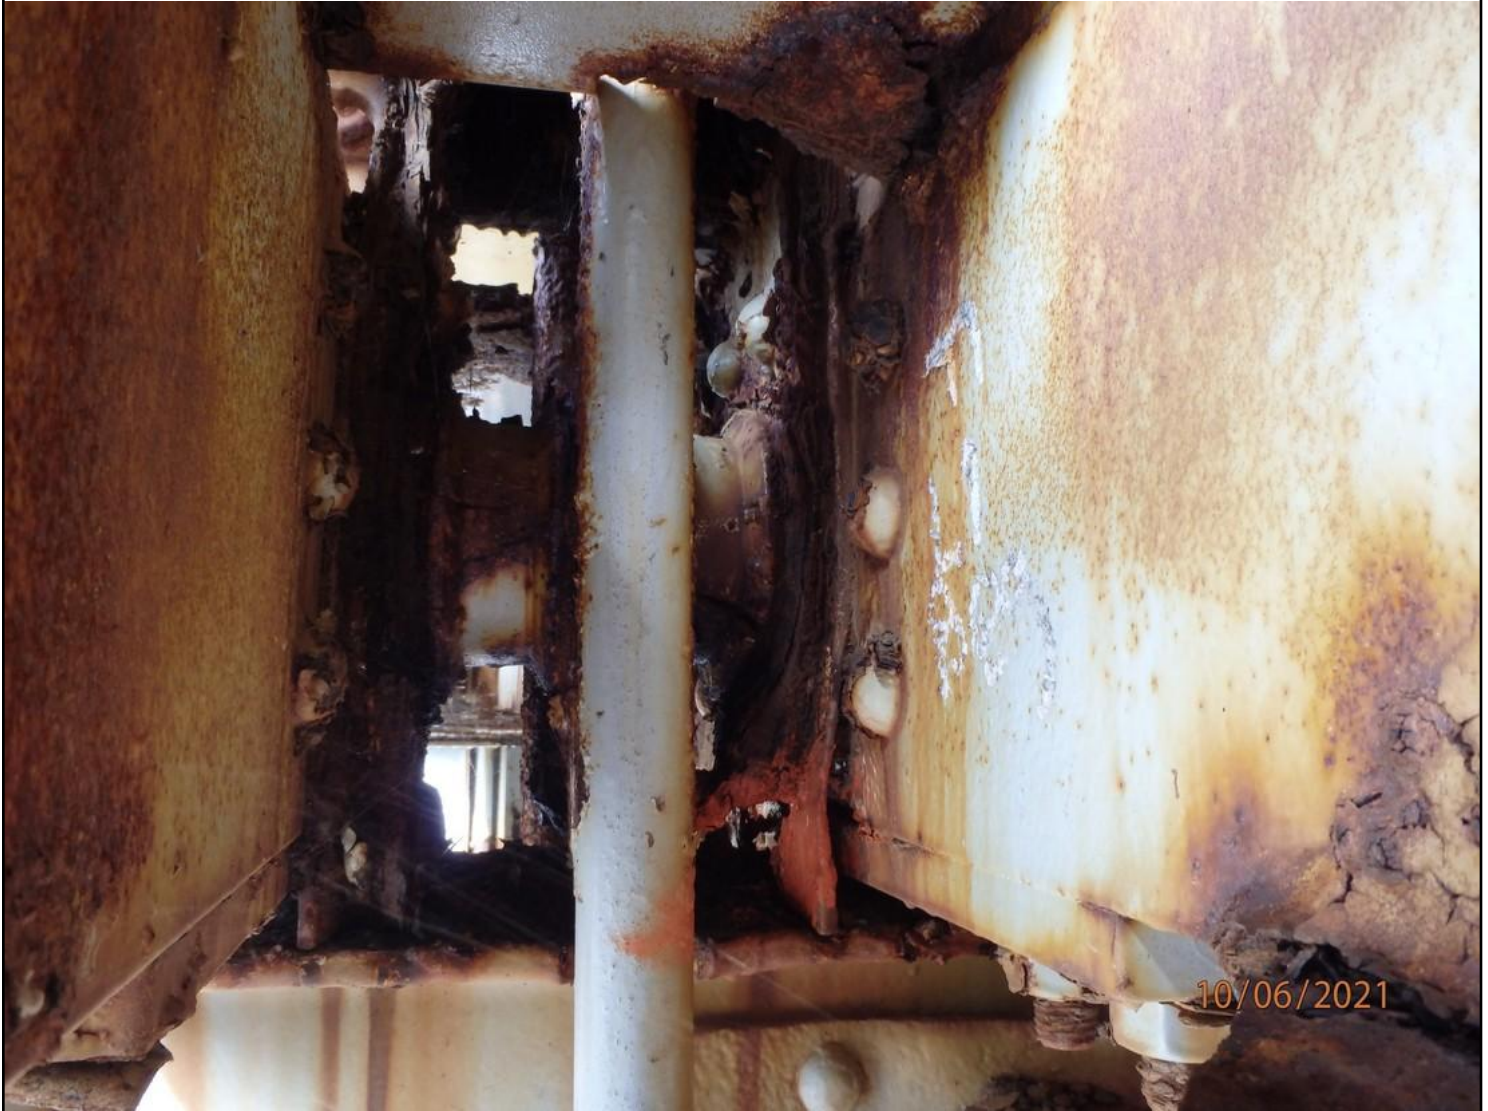
Left Truss at L1 (Floorbeam FB1): The inboard (right) channel web for L0L1 at L1 has a perforation that is 5" L x ¾" H above the bottom flange. Overall section loss is estimated at 10% for the entire member. The inboard (right) vertical member attached to the bottom chord is fully corroded along its bottom adjacent to the perforation to the bottom chord member (Photos 2 to 4).

**Attachment Description:** Left Truss at L1, Inboard (Right) Channel Left Face, Begin Side Web Perforation, Looking:  
End

This hybrid bridge is not able to be load rated with NYSDOT's BrR software. A Level One load rating is strongly recommended to assess the significant deterioration which has occurred since the 1992 rehab.

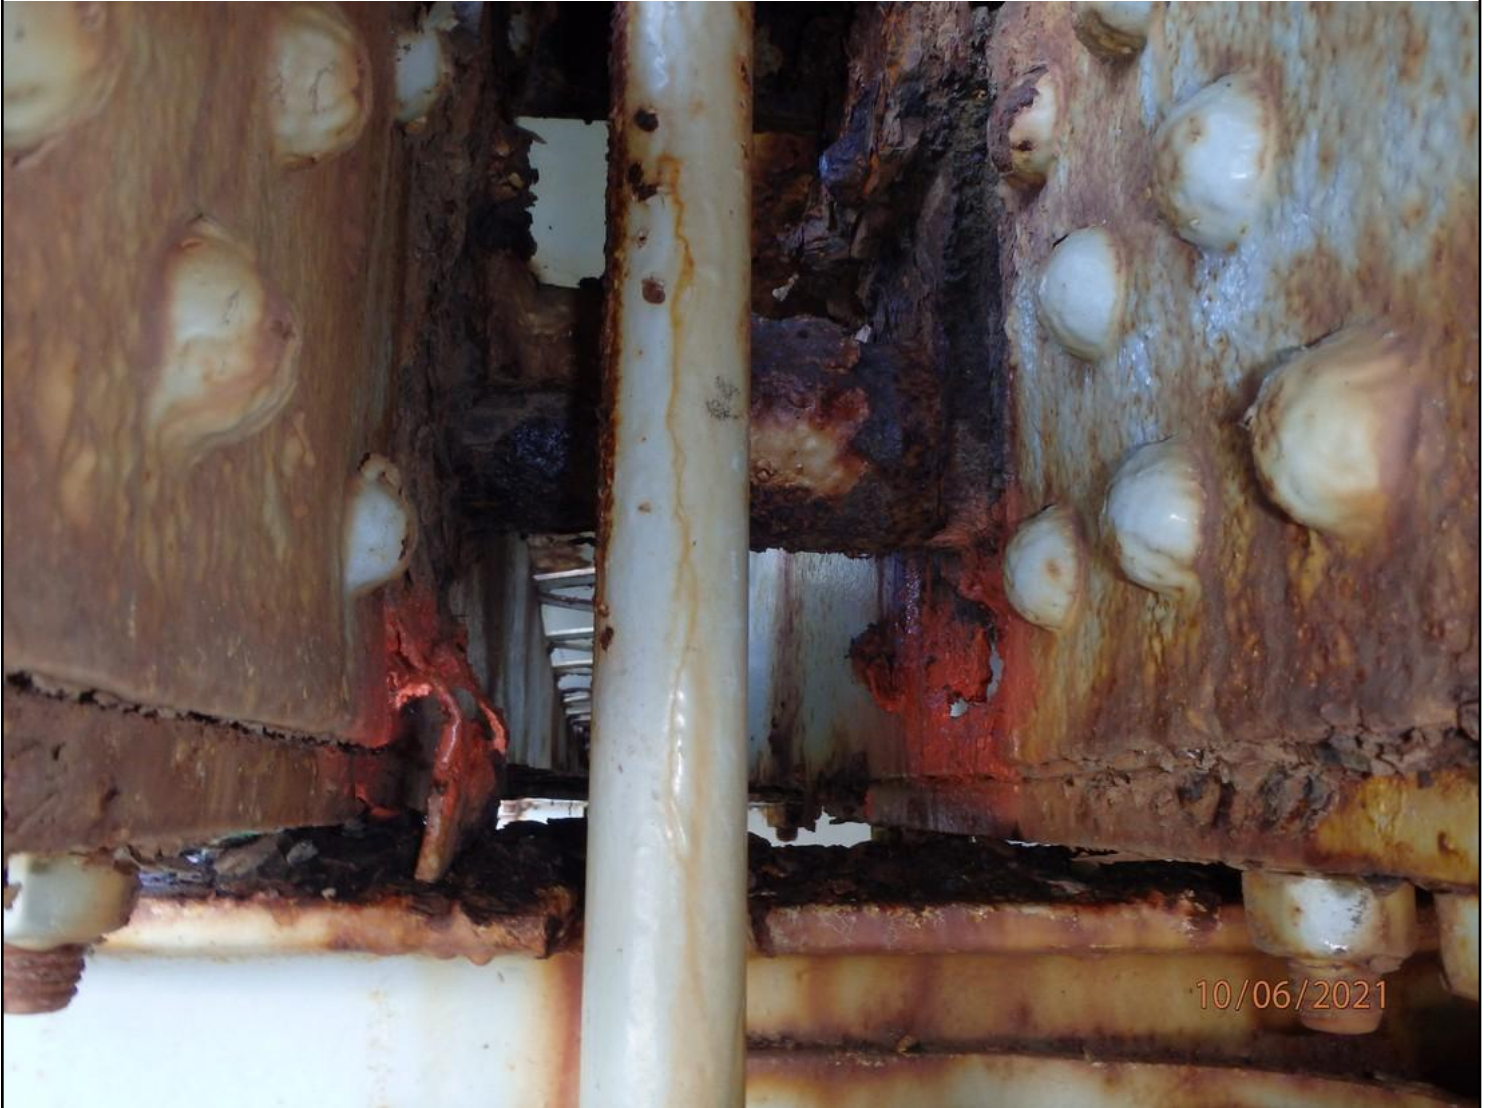
**Attachment Description: Left Truss at L11, Both Channel Web Perforation, Begin Side, Looking: End**

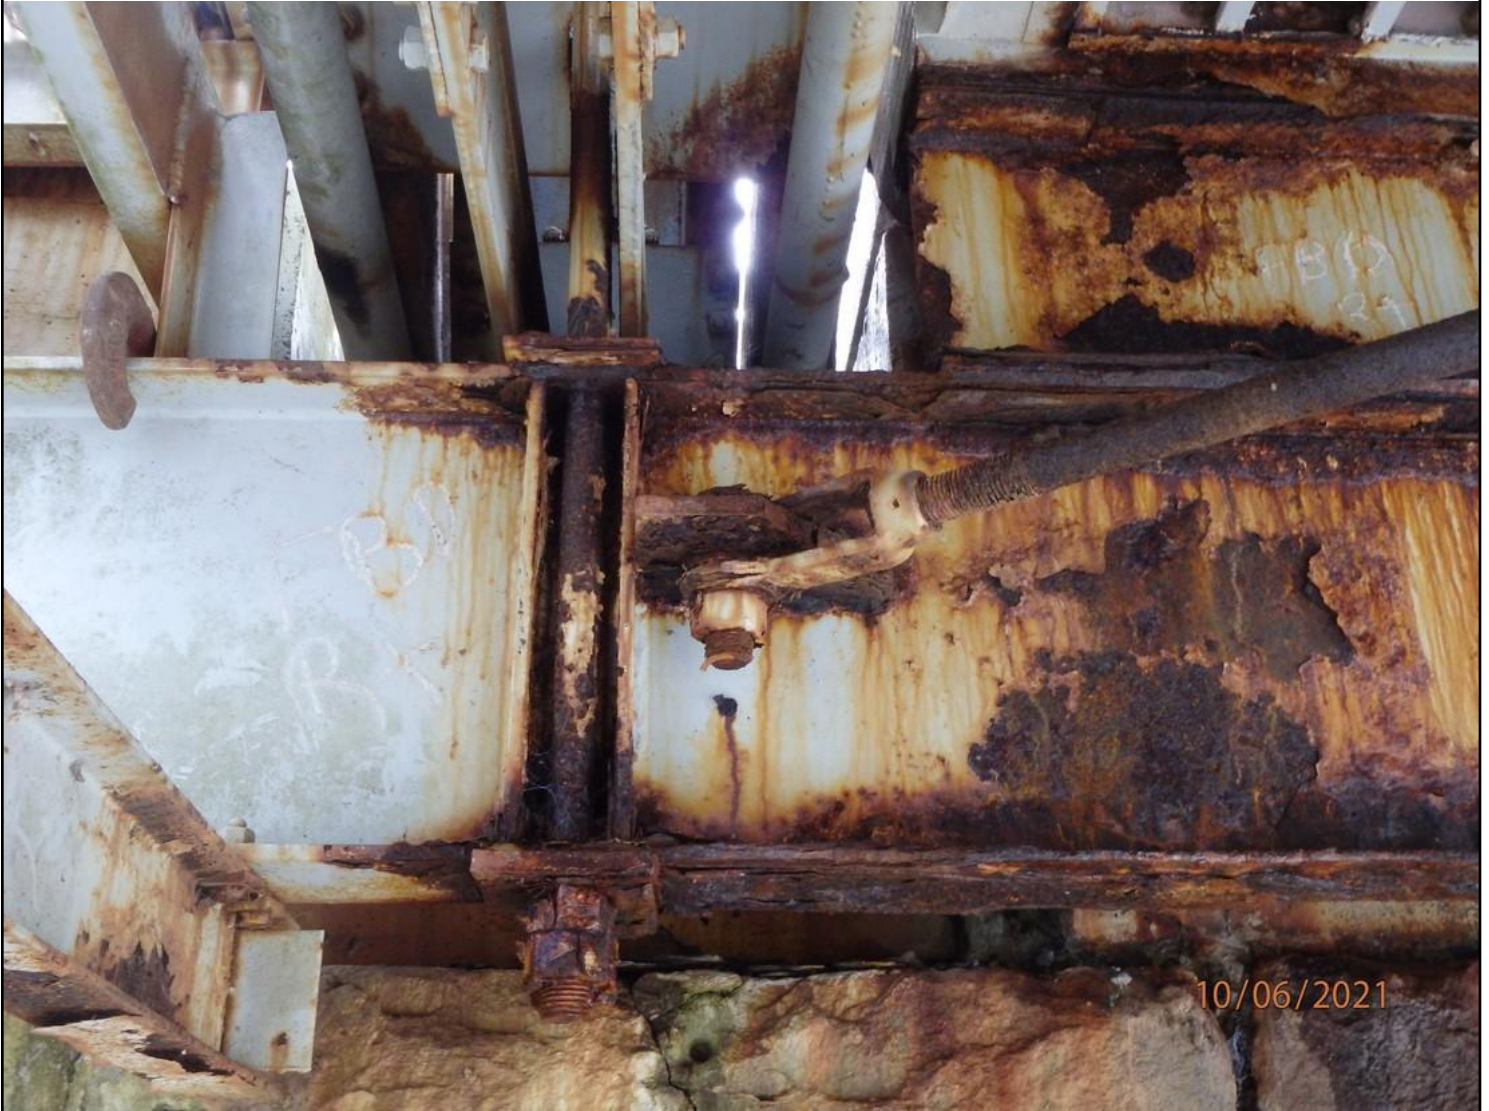
At the begin floorbeam (FB0) at right side, there is heavy corrosion and section losses with perforations to the webs of both floorbeams, approximately 2' from the hanger rods (from the inside of the rods, directly under the deck). There are two floorbeams welded together with the top floorbeam being called a 'sleeper' floorbeam. Both webs are approx. 0.3" thick which was field measured during the previous inspection in a clean non-corroded area with D-meter readings taken on both the top and bottom floorbeams (it was difficult to access during this inspection due to how close the rigging pick could get with set up being hard with high water level and velocity). The top 'sleeper' floorbeam, has a perforation on the lower web for a 14" L x 2" H. The section losses calculated with the hole is approximately 50%. The bottom floorbeam has section loss readings at 50%, with a 1/2" diameter hole in the lower portion of the web. No significant changes in section losses since the last inspection in 2020.

A yellow flag is issued due to the nature of this bridge and its configuration. This section loss at the floorbeam has gotten worse over the past several inspections. At this time no distress to the floorbeam or hanger rods was observed.

**Attachment Description:** Floorbeam FB0 at Right at Hanger Rod Connection, Section Loss to Rod, Looking: Begin

This hybrid bridge is not able to be load rated with NYSDOT's BrR software. A Level One load rating is strongly recommended to assess the significant deterioration which has occurred since the 1992 rehab.
